Ref: Oasis Lake, June 2015

The following report summarizes initial water quality data collected for Oasis Lake on 04 June 2015. Similar data will be reported each month and, once sufficient data has been collected, will be used to generate graphs to track changes in water quality. This report also includes field data sheets reflecting lake and mechanical system conditions each week during the month.

LABORATORY REPORTS

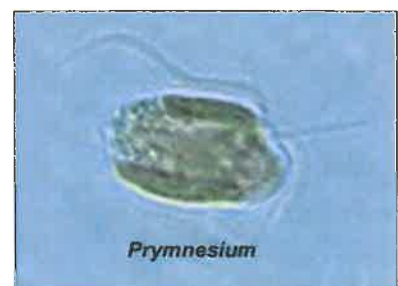
The total algae density in the lake was essentially unchanged at 2.56×10^5 cells per mL; considered in the elevated category for an urban reservoir in metro-Phoenix. Increased day length, water temperature, and solar intensity are likely responsible. The dominant

alga in Oasis Lake changed to *Spirulina*, a filamentous blue-green (Cyanophyta) form. Although blue-green algae are not typically desirable, *Spirulina* tends to be one of the least problematic. Diatoms made up about 20 percent of the total population. The potentially toxic (to fish) alga, *Prymnesium parvum*, was not detected in the lake water.

A dye application was made on 11 June to reduce light penetration into the water column and reduce available light to algae, and to improve water color.

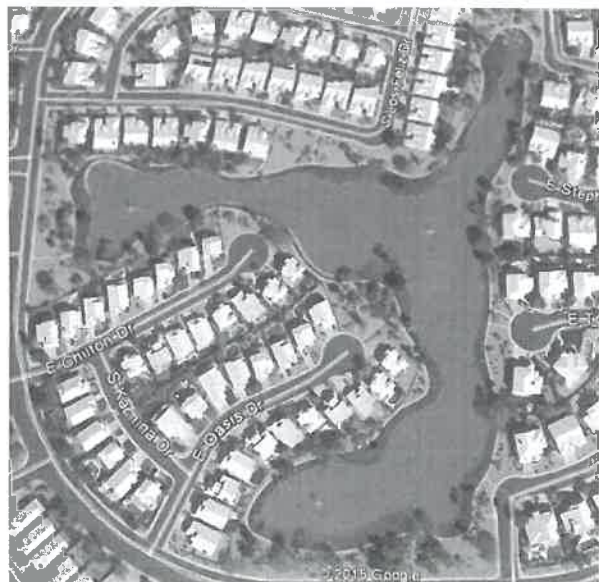
OASIS AT ANOZIRA FIELD INSPECTION FORM (

Details: all aerators working (2 poorly)

Los Feliz: operational Screens cleared Problem Details: Leak From wall

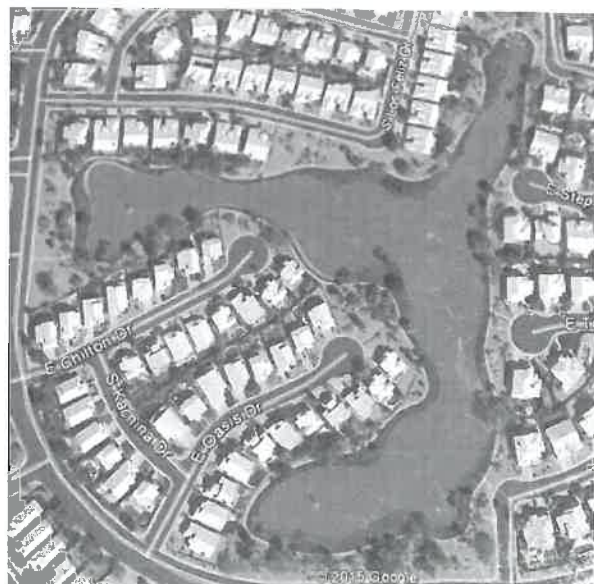
OASIS AT ANOZIRA FIELD INSPECTION FORM (

Details: 10 gallons Aquadye Lake
All aerators running (2 poorly)

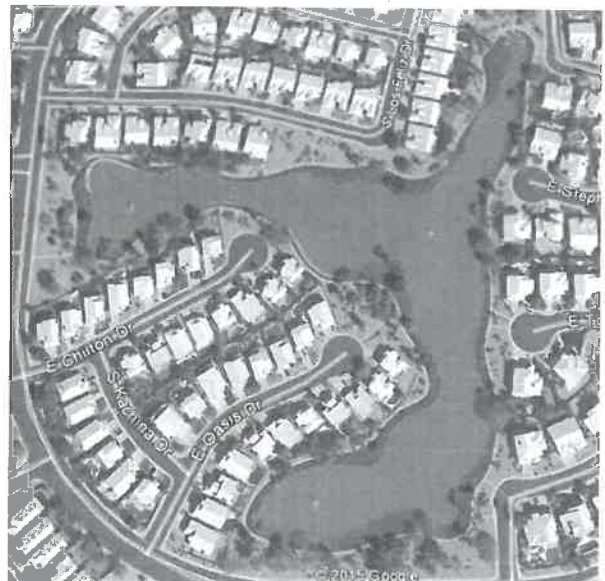
OASIS AT ANOZIRA FIELD INSPECTION FORM (

Details: All aerator work (2 poorly)

Los Feliz: operational Screens cleared Problem Details: leak in wall

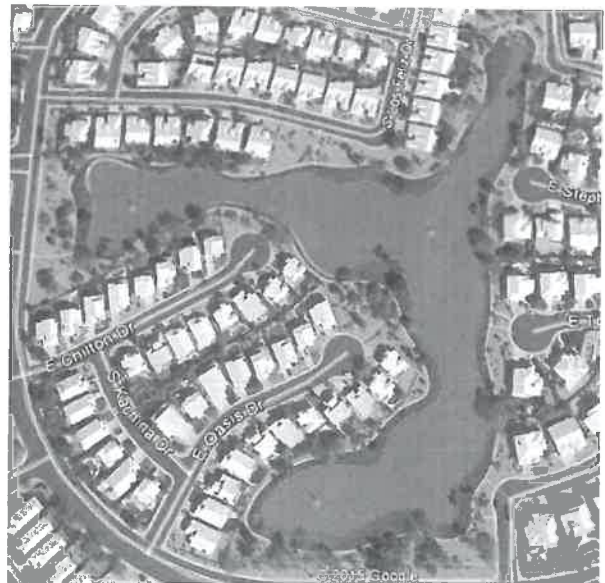
OASIS AT ANOZIRA FIELD INSPECTION FORM (

Details: 2 weak

Los Feliz: operational Screens cleared Problem Details: OFF
