AQUATIC CONSULTING & TESTING, INC.

Ref: Oasis Lake, July 2015

The following report summarizes initial water quality data collected for Oasis Lake on 02 July 2015. Similar data have been reported each month and are used in this report to generate the initial graphs that will be used for tracking changes in water quality. The report also includes field data sheets reflecting lake and mechanical system conditions each week during the month.

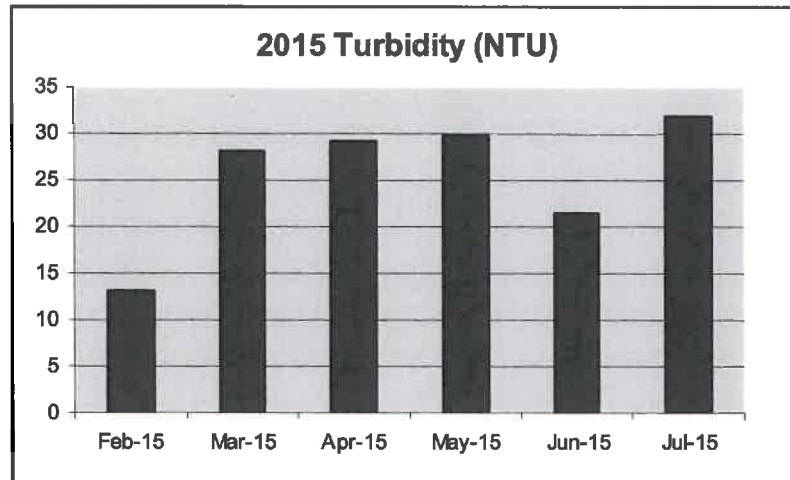
Turbidity: The turbidity of the lake water increased to 26.9 NTU. Water turbidity is impacted by dissolved and particulate matter in the water. As turbidity increases, clarity and aesthetic quality decreases. Increased turbidity may have resulted from storm water discharges in late June.

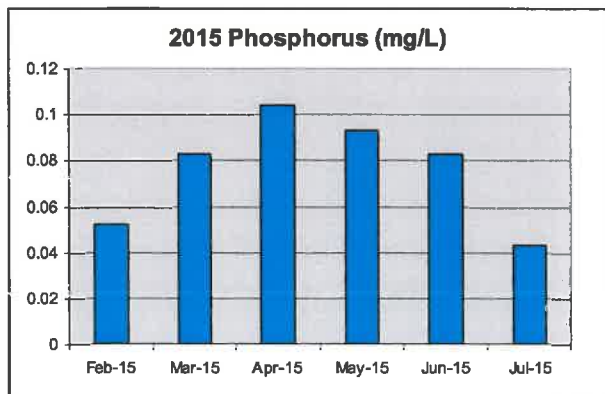
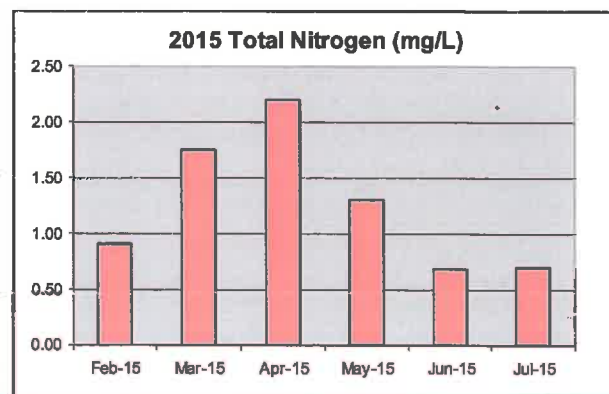
The total nitrogen concentration was relatively unchanged at 0.70 mg/L as N. The phosphorus concentration decreased to 0.043 mg/L as P. These data indicate that, although decreasing in concentration, the lake has sufficient nutrients to support a high density algae population which is reflected in the phytoplankton data.

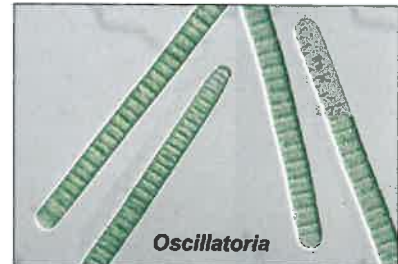
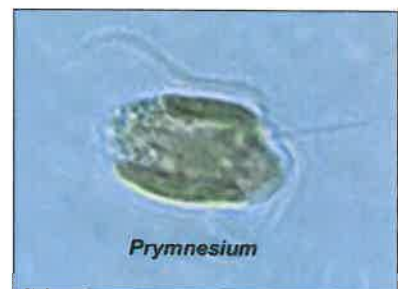
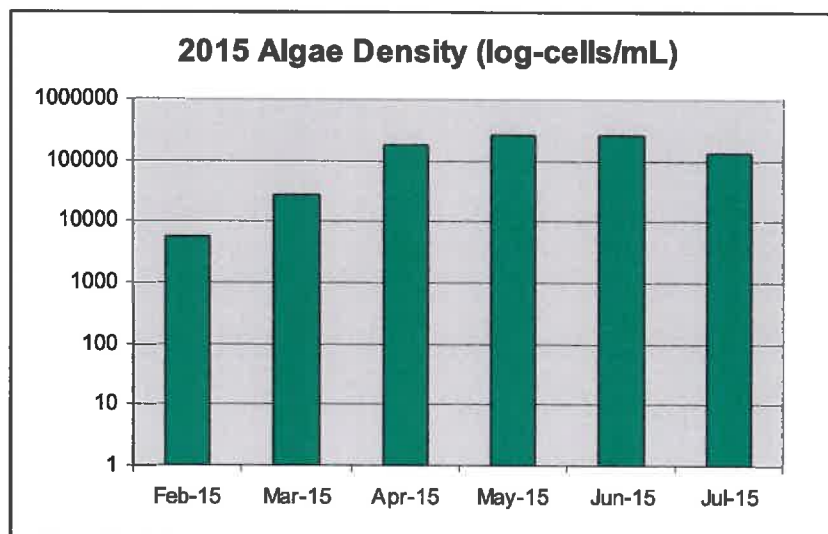
The total algae density in the lake decreased to 1.29×10^5 cells per mL; considered in the elevated category for an urban reservoir in metro-Phoenix. Increased day length, water temperature, and solar intensity are likely responsible. The dominant alga in Oasis Lake was *Oscillatoria*, a filamentous blue-green (Cyanophyta) form. Blue-green filamentous algae tend to produce stringers on the lake edge or floating masses on the lake surface. However, this did not occur. The potentially toxic (to fish) alga, *Prymnesium parvum*, was not detected in the lake water.

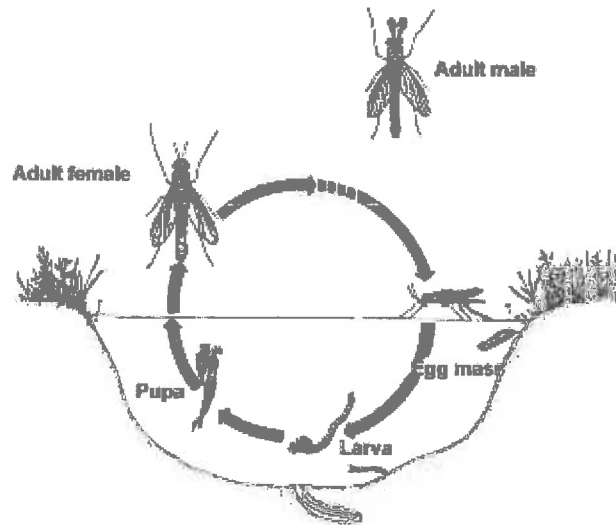
eggs settle to the lake bottom and hatch in a few days. Larvae develop and grow in the superficial sediments over a three to four week period. In about 30 days the insect larvae become pupae, rise in the water column, and emerge as adult flies. The life cycle is shown diagrammatically below. The Adults tend to swarm at dusk and dawn and become a nuisance. They fly into residents' eyes and mouths, congregate under eaves of houses, and leave a sticky messy residue when they die. Management techniques may include stocking of bottom-feeding fishes to consume the larvae and/or application of bacterial or chemical larvicides.

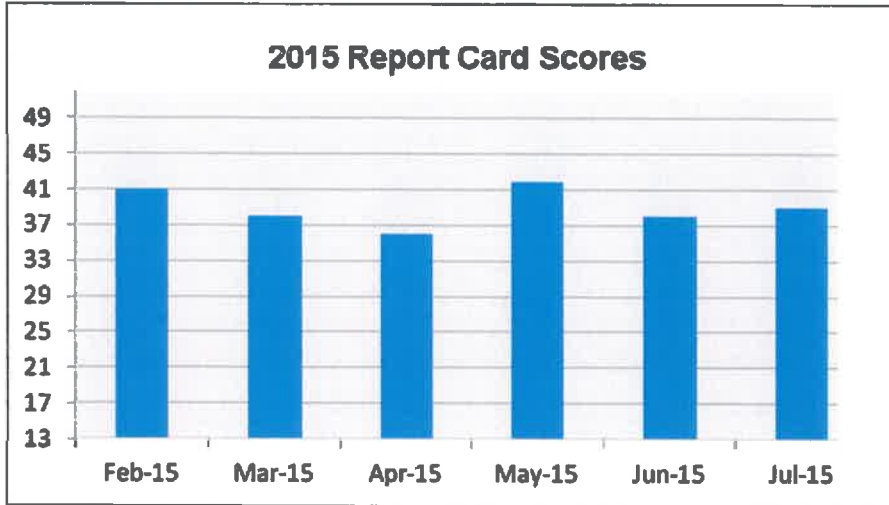
The water quality data are summarized on the attached Oasis Lake Report Card. Each salient parameter has been qualitatively evaluated and then assigned a numeric value for comparison and tracking purposes. The overall rating increased from 38 to 39, primarily as a result of improved pH and a lower phosphate concentration. Report card scores for the year are summarized below.
