AQUATIC CONSULTING & TESTING, INC.

Ref: Oasis Lake, September 2015

The following report summarizes initial water quality data collected for Oasis Lake on 03 September 2015. Similar data have been reported each month and are used in this report to generate the initial graphs that will be used for tracking changes in water quality. The report also includes field data sheets reflecting lake and mechanical system conditions for each week during the month.

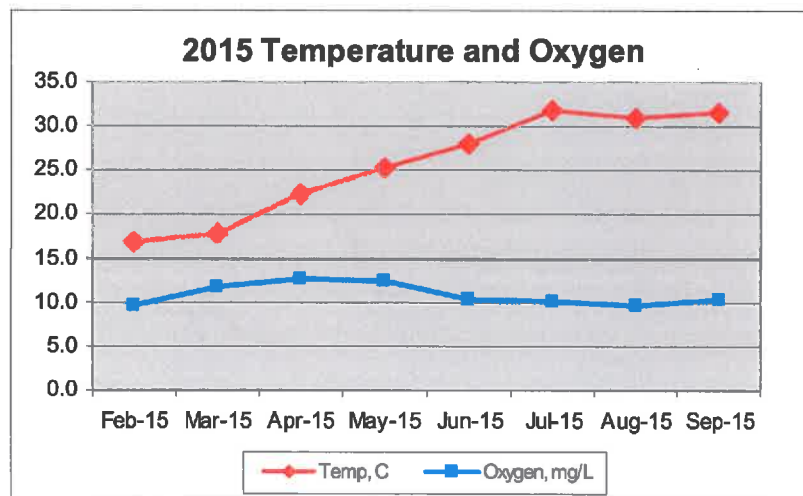
Temperature, Oxygen, and pH: Water temperature was 31.7 C (89 F) and the dissolved oxygen concentration was 10.5 mg/L. The amount of oxygen that can dissolve in water is temperature dependent; colder water can hold more oxygen than warmer water. At the time of sampling and despite a reduction in oxygen, the oxygen saturation was still over 100 percent, indicating maximum oxygenation and adequate operation of the aeration system.

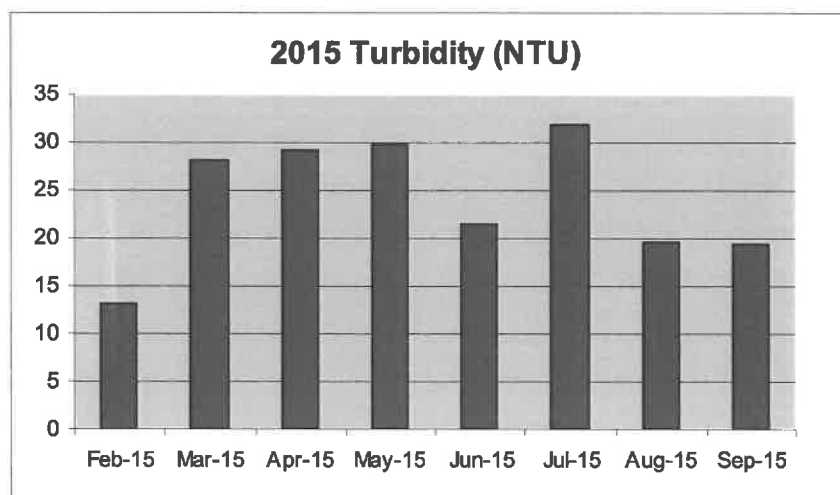
Turbidity: The turbidity of the lake water was relatively unchanged at 19.3 NTU. Water turbidity is impacted by dissolved and particulate matter in the water. As turbidity increases, clarity and aesthetic quality decreases. Turbidity appeared not to change despite measurable precipitation and storm water runoff during September.

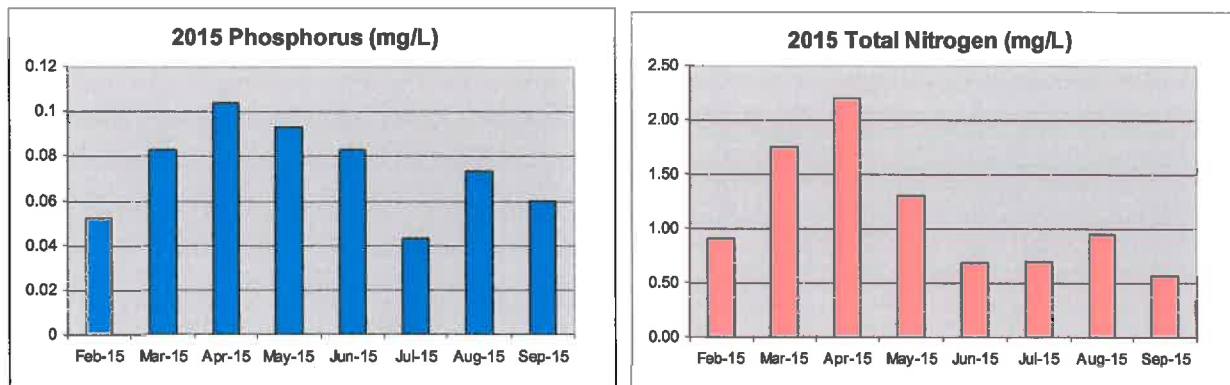
The total nitrogen concentration decreased to 0.57 mg/L as N. The phosphorus concentration also decreased to 0.060 mg/L as P. These data indicate that the lake still has sufficient nutrients to support a high density algae population. However, the phytoplankton data, below, indicate reduced numbers of algae cells.

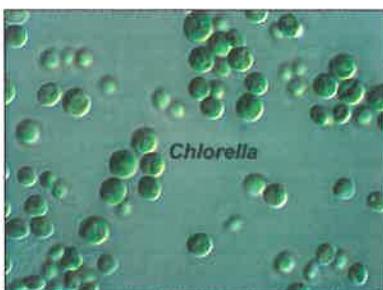
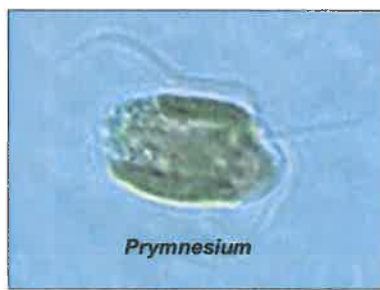
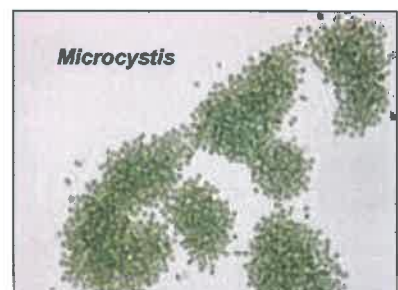
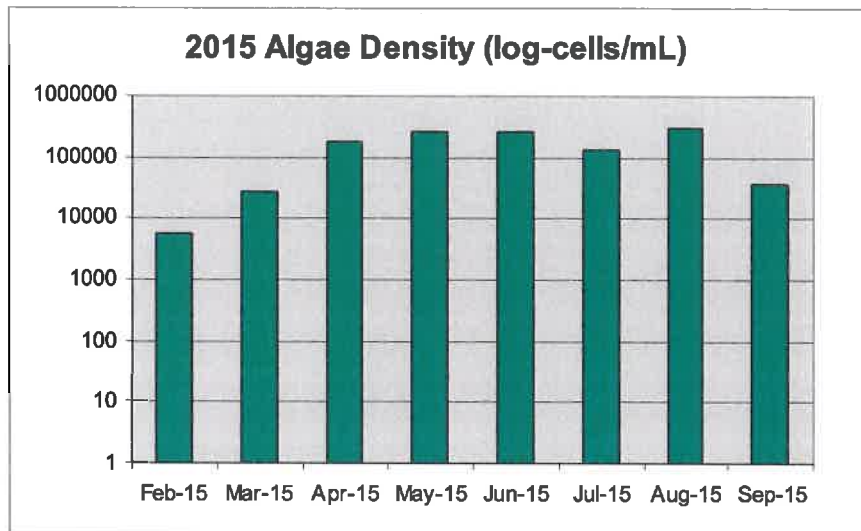
The total algae density in the lake decreased to 3.78×10^4 cells per mL; considered in the moderate category for an urban reservoir in metro-Phoenix. Decreased day length and solar intensity are likely responsible. The dominant alga in Oasis Lake was *Chlorella*, a unicellular green (Chlorophyta) form. This alga is usually not problematic but can turn the water a bright green color if in sufficient density. This was not the case in Oasis Lake. A minor bloom of the blue-green alga, *Microcystis* occurred near the end of the month. The alga forms surface accumulations and swirls. The alga prompted the second aquatic dye application. The potentially toxic (to fish) alga, *Prymnesium parvum*, was not detected in the lake water.

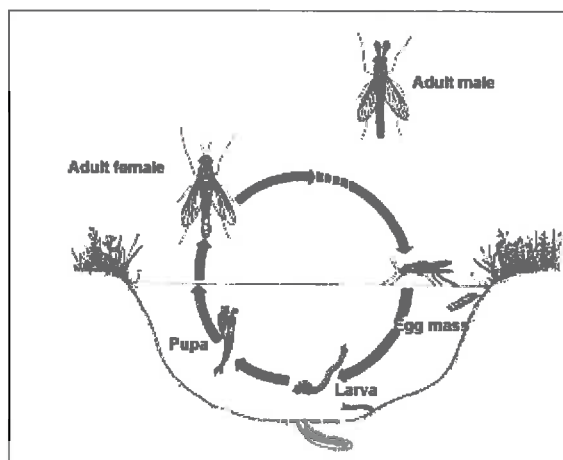
30 days the insect larvae become pupae, rise in the water column, and emerge as adult flies. The life cycle is shown diagrammatically below. The Adults tend to swarm at dusk and dawn and become a nuisance. They fly into residents' eyes and mouths, congregate under eaves of houses, and leave a sticky messy residue when they die. Management techniques may include stocking of bottom-feeding fishes to consume the

larvae and/or application of bacterial or chemical larvicides.
Minimal midge fly adults were detected during the month.

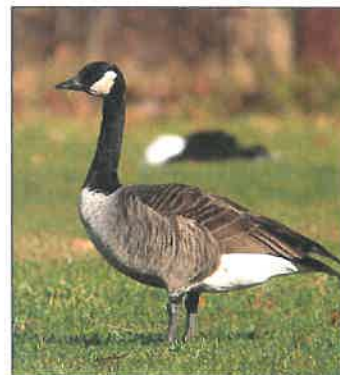
Based on the Arizona Game & Fish Department scale, the lake condition in terms of waterfowl was good during the month. A minor change in variety and number of ducks was observed and a few geese (Canada geese, shown at right) were observed during routine inspections. Canada geese consume grass and deposit fecal matter on land and water. Cormorants were not observed.

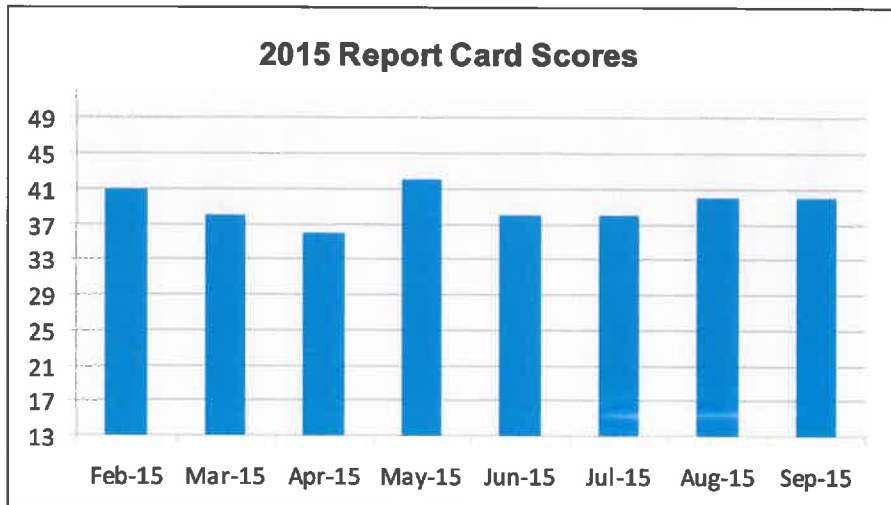
The water quality data are summarized on the attached Oasis Lake Report Card. Each salient parameter has been qualitatively evaluated and then assigned a numeric value for comparison and tracking purposes. The overall rating was unchanged at 40. Report card scores for the year are summarized below.
