# AQUATIC CONSULTING & TESTING, INC.

Ref: Oasis Lake, October 2015

The following report summarizes water quality data collected for Oasis Lake on 08 October 2015. Similar data have been reported each month and are used in this report to generate the graphs that will be used for tracking changes in water quality. The report also includes field data sheets reflecting lake and mechanical system conditions for each week during the month.

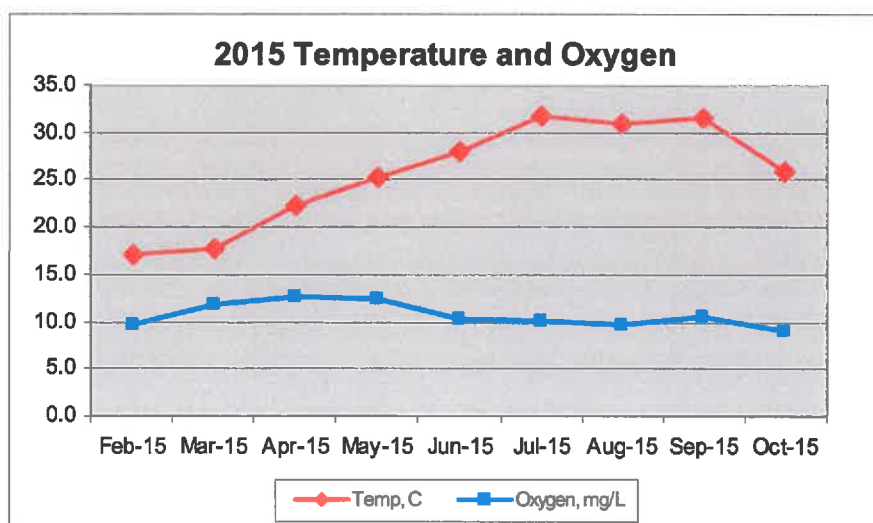
**Temperature, Oxygen, and pH:** Water temperature was 26.0 C (79 F) and the dissolved oxygen concentration was 9.1 mg/L. The amount of oxygen that can dissolve in water is temperature dependent; colder water can hold more oxygen than warmer water. At the time of sampling and despite a reduction in oxygen, the oxygen saturation was still over 100 percent, indicating maximum oxygenation and adequate operation of the aeration system.

The dissolved oxygen content was also satisfactory for the fishery. The table below shows the USEPA criteria for dissolved oxygen in warm water fisheries.

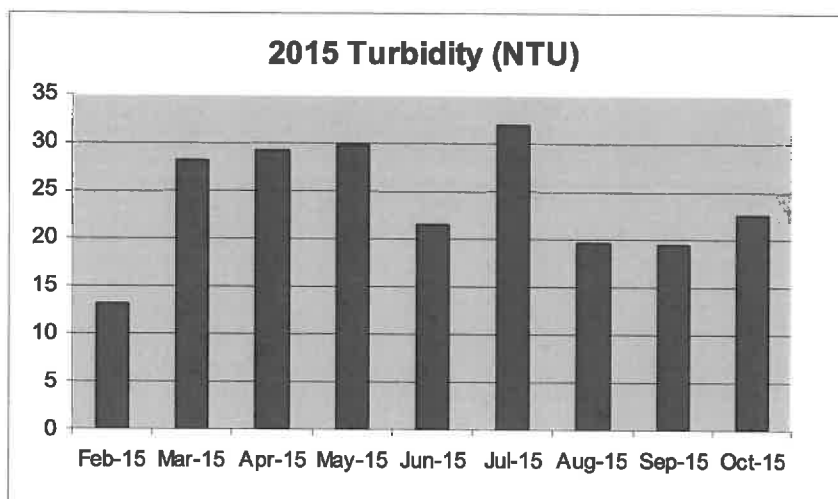
**Turbidity:** The turbidity of the lake water increased slightly to 22.5 NTU. Water turbidity is impacted by dissolved and particulate matter in the water. As turbidity increases, clarity and aesthetic quality decreases.

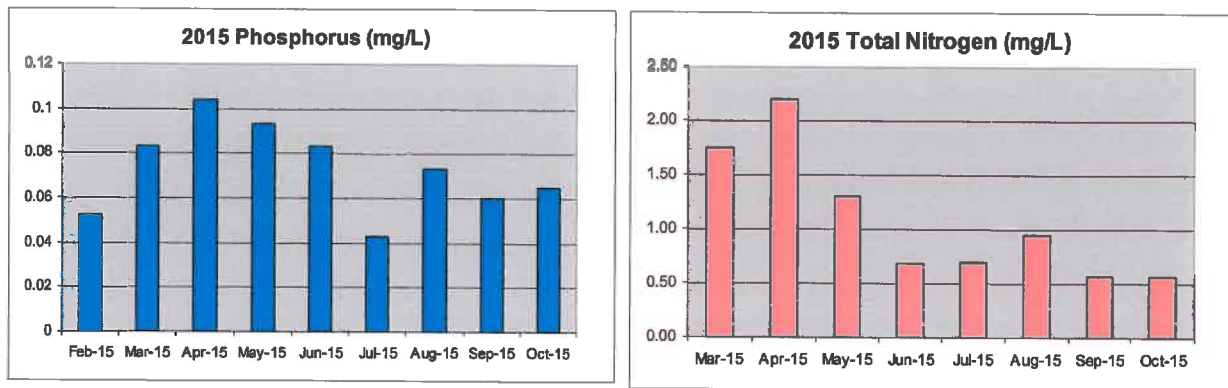
The total nitrogen concentration was unchanged at 0.56 mg/L as N. The phosphorus concentration was also stable at 0.065 mg/L as P. These data indicate that the lake still has sufficient nutrients to support a high density algae population. The phytoplankton data, below, indicate increased numbers of algae cells.

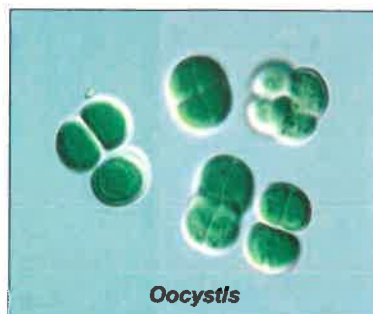
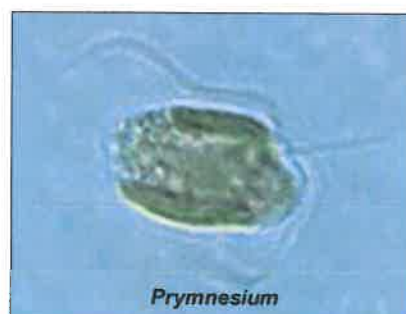
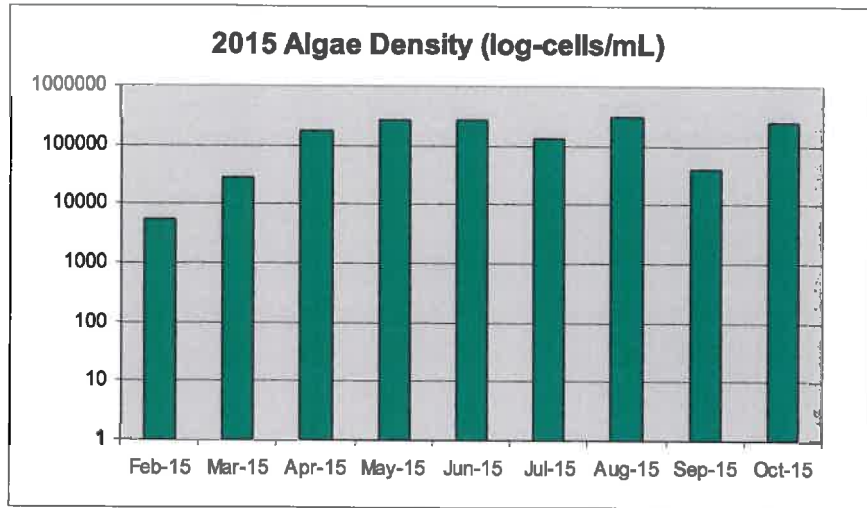
The total algae density in the lake increased to  $2.50 \times 10^5$  cells per mL; considered in the elevated category for an urban reservoir in metro-Phoenix. The dominant alga in Oasis Lake was *Chroococcus*, a colonial blue-green (Cyanophyta) form. This alga is usually can become problematic and cause lake water to become very green, turbid, and sometimes form surface swirls. This was case in late October in Oasis Lake. Surface swirls formed in the western cover, but were eliminated by an algaecide application. The potentially toxic (to fish) alga, *Prymnesium parvum*, was not detected in the lake water. Submerged weeds were not detected in the lake.

A single algaecide application was made to the western cove of the lake to help reduce surface swirls of algae.

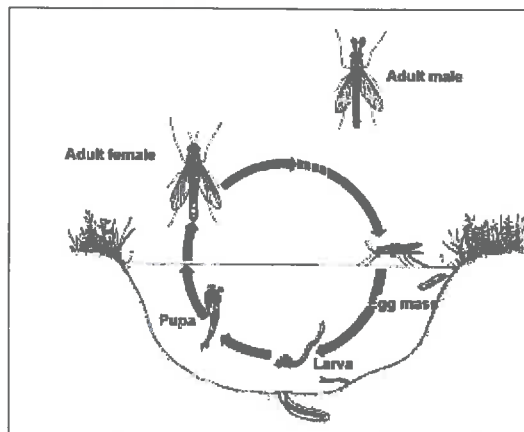
30 days the insect larvae become pupae, rise in the water column, and emerge as adult flies. The life cycle is shown diagrammatically below. The Adults tend to swarm at dusk and dawn and become a nuisance. They fly into residents' eyes and mouths, congregate under eaves of houses, and leave a sticky messy residue when they die. Management techniques may include stocking of bottom-feeding fishes to consume the larvae and/or application of bacterial or chemical larvicides.

Minimal midge fly adults were detected during the month.

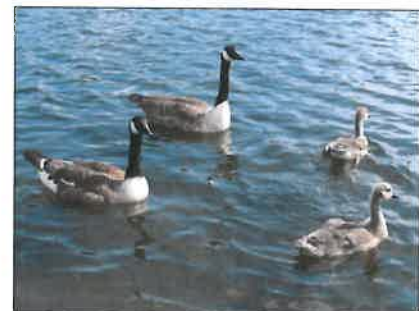
Based on the Arizona Game & Fish Department scale, the lake condition in terms of waterfowl was good during the month. No significant change in variety and number of ducks was observed. A few geese (Canada geese, shown at right) were observed during routine inspections. Canada geese consume grass and deposit fecal matter on land and water. Cormorants were not observed.

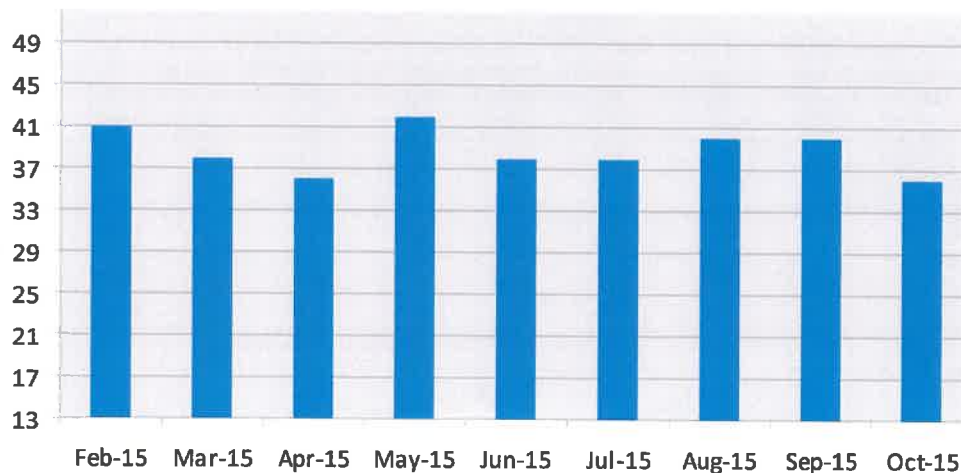
**2015 Report Card Scores**

The water quality data are summarized on the attached Oasis Lake Report Card. Each salient parameter has been qualitatively evaluated and then assigned a numeric value for comparison and tracking purposes. The overall rating fell to 36 as a result of increased algae, turbidity, and bacteria. Report card scores for the year are summarized below.
