# **AQUATIC CONSULTING & TESTING, INC.**

Ref: Oasis Lake, Current Status Report and Water and Sediment Depth Survey

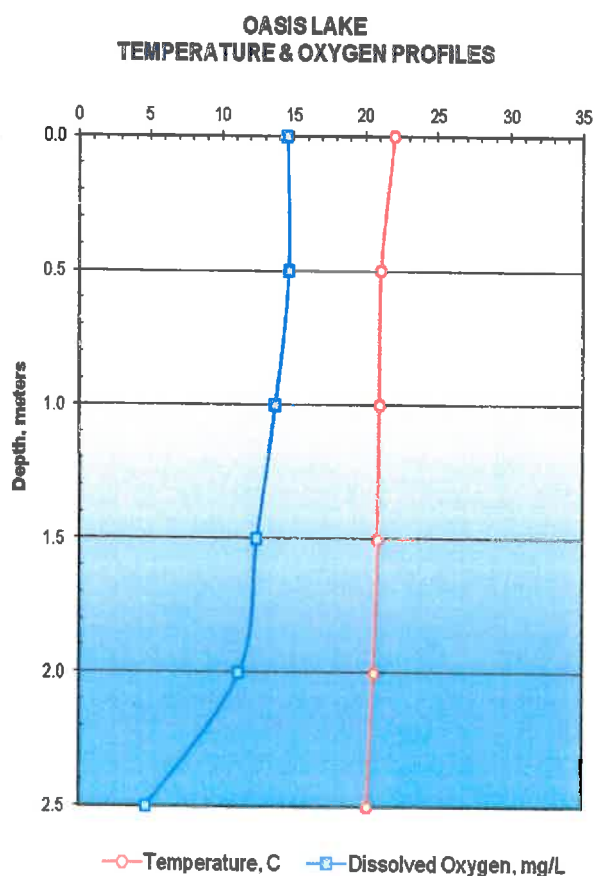
**Temperature and Oxygen:** The vertical profile of temperature and oxygen for the deep portion of the lake is presented below. The data indicate some slight surface heating was occurring at the time of data collection. The oxygen concentration decreased with depth indicating incomplete circulation and high organic loading in the sediment. The condition is likely to worsen when higher water temperatures occur during the summer. Expansion of the aeration system should be considered.

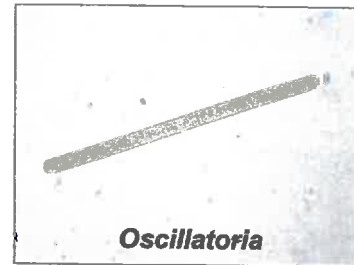
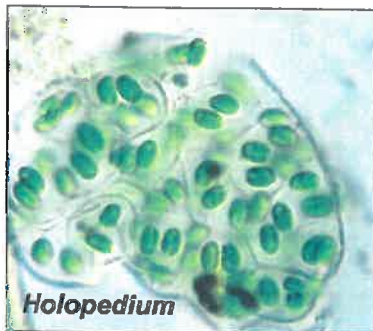
**Phytoplankton:** The lake had a reasonable amount of diversity in the phytoplankton. (suspended algae), with 14 genera of algae identified. The dominant alga was the blue-green (Cyanophyta) filament, *Oscillatoria*. This alga can be problematic, producing strings along the lake edge or developing into floating mats on the water surface. It is also resistant to many algaecides. In terms of aesthetics, several other blue-green algae were present in the sample, including

*Merismopedia*, *Spirulina*, and *Holopedium*. Although the cell count was moderate, the chlorophyll-a concentration was elevated (99.9 ug/L) indicating substantial algal biomass in the water column. The biomass was responsible for the less-than-desired water transparency. The chlorophyll to pheophytin ratio indicated the algae were in optimum physiological condition at the time of sampling.

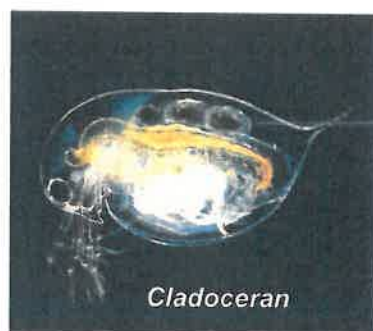
**Zooplankton:** Zooplankton provides a natural means of phytoplankton control. Zooplankton is composed of nearly microscopic invertebrates that filter or selectively feed on particulates, including algae cells. Cladocerans and copepods are generally preferred, as they consume larger particles than rotifers.

The zooplankton density was nearly 300,000 per cubic meter indicating a very good potential for natural algae control. However, rotifers made up nearly 100 percent of the population.
