AQUATIC CONSULTING & TESTING, INC.

Ref: Oasis Lake, February 2017

The following report summarizes water quality data collected for Oasis Lake on 08 February 2017. Similar data have been reported each month and are used in this report to generate the graphs that are used for tracking changes in water quality. The report includes field data sheets reflecting weekly lake and mechanical system conditions during the month.

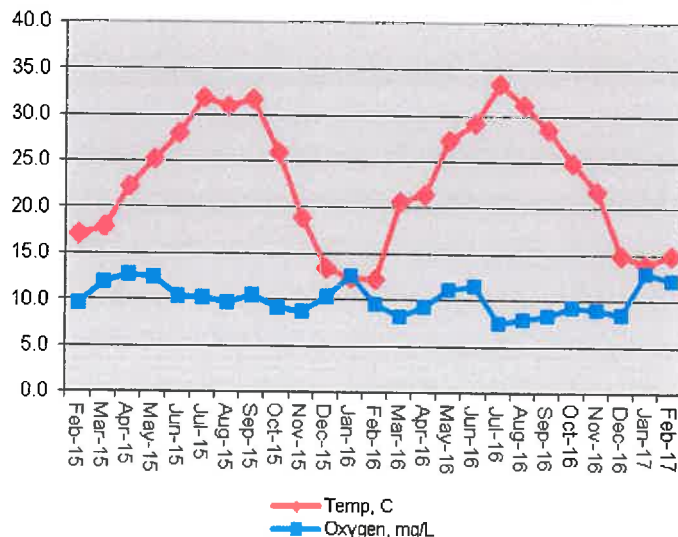
2015-2017 Temperature and Oxygen

Temperature, Oxygen, and pH: Water temperature increased to 14.9 C (59 F) and the dissolved oxygen concentration remained high at 12.2 mg/L. At the time of sampling, the oxygen saturation was >100 percent, indicating very good oxygenation and adequate operation of the aeration system. The dissolved oxygen content was also satisfactory for the fishery.

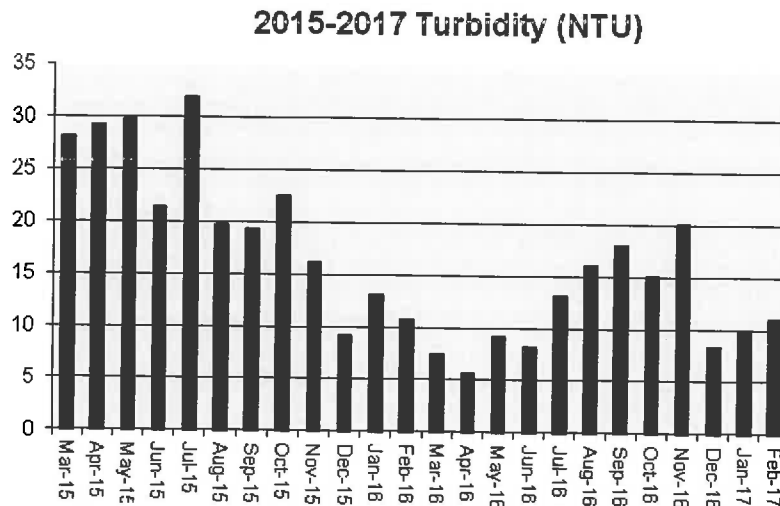
Turbidity: The turbidity of the lake water increased slightly to 11.0 NTU. Water turbidity is impacted by dissolved and particulate matter in the water, including the dye that is now routinely added for algae and weed management. As turbidity increases, clarity decreases. Accordingly, water clarity declined during February.

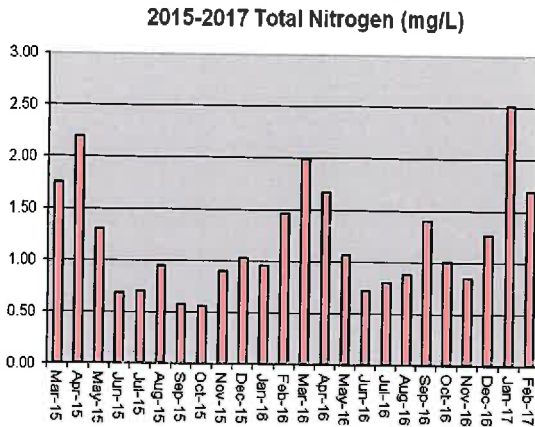
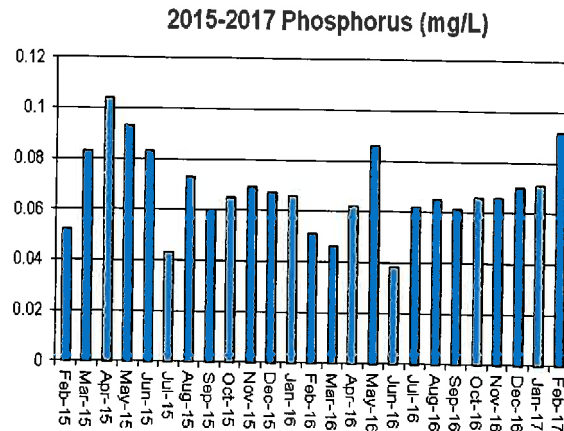
The total nitrogen concentration was moderate and showed a decrease at 1.69 mg/L as N. The phosphorus concentration increased to 0.092 mg/L as P. These data indicate that the lake has sufficient nutrients to support a high-density algae population. The phytoplankton data presented below indicate an increase in algae cell density.

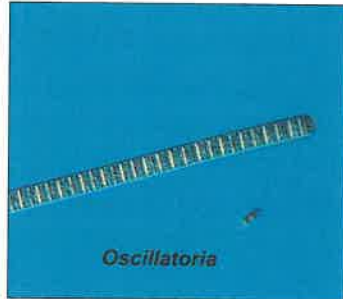
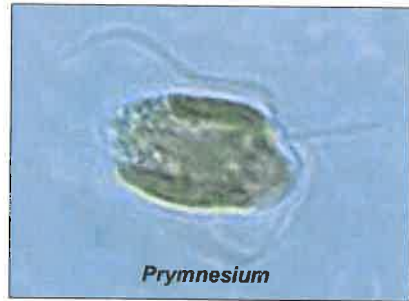
The dominant alga in Oasis Lake was *Oscillatoria*, a blue-green filament. This alga can become problematic, forming bottom or surface mats or stringers along the lake edge. However, these conditions were not observed.

The potentially toxic (to fish) alga, *Prymnesium parvum*, was not detected in the lake water.

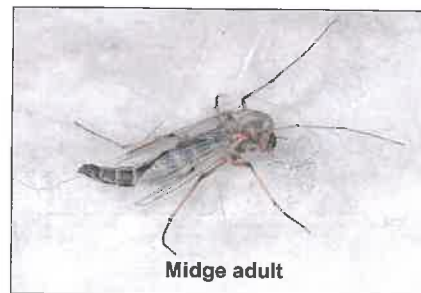
Although air and water temperatures increased, few adult midge flies were detected during the month.

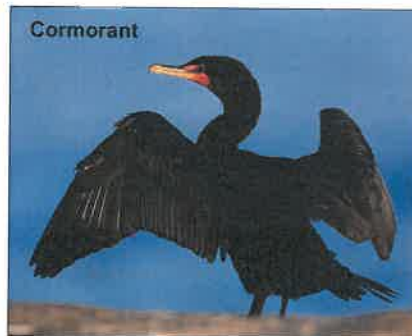
Based on the Arizona Game & Fish Department scale, the lake condition in terms of waterfowl remained undesirable during January with about five (5) ducks per acre. Cormorants were occasionally observed and several Canada geese were frequent visitors. Cormorants are diving birds that feed on small fish.

Canada geese destroy turf and contribute fecal matter to the common areas and water.
