AQUATIC CONSULTING & TESTING, INC.

Ref: Oasis Lake, November 2017

The following report summarizes water quality data collected for Oasis Lake on 01 November 2017. Similar data have been reported each month and are used in this report to generate the graphs that are used for tracking changes in water quality. The report includes field data sheets reflecting weekly lake and mechanical system conditions during the month.

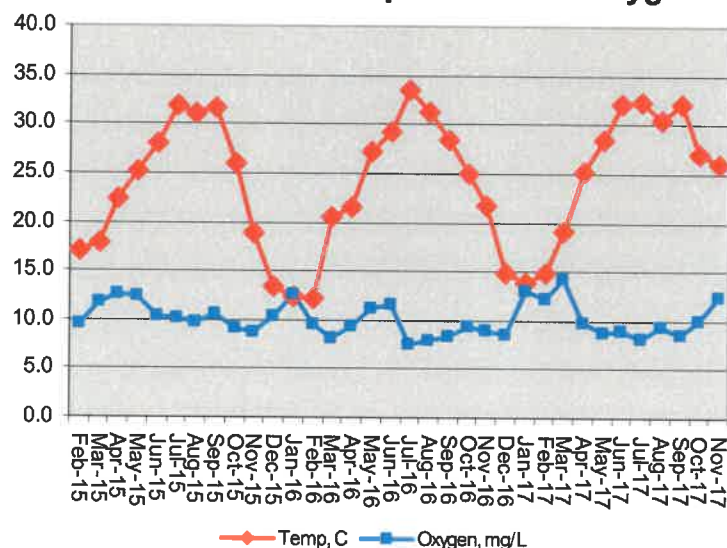
2015-2017 Temperature and Oxygen

Temperature, Oxygen, and pH: Water temperature decreased to 26.0 C (79 F) and the dissolved oxygen concentration remained relatively high at 12.3 mg/L. At the time of sampling, the oxygen saturation was >100 percent, indicating very good oxygenation and adequate operation of the aeration system. The dissolved oxygen content was also satisfactory for the fishery.

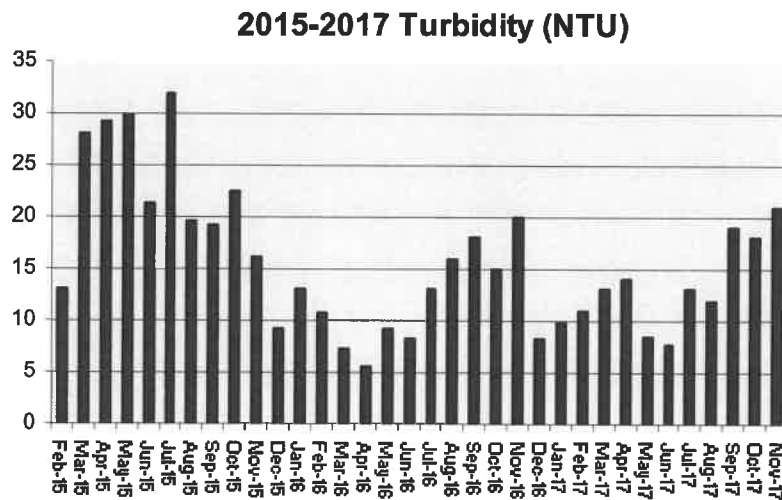
Turbidity: The turbidity of the lake water increased slightly to 21 NTU. Water turbidity is impacted by dissolved and particulate matter in the water, including the dye that is now periodically added for algae and weed management. As turbidity increases, clarity decreases. Accordingly, water clarity declined slightly during November.

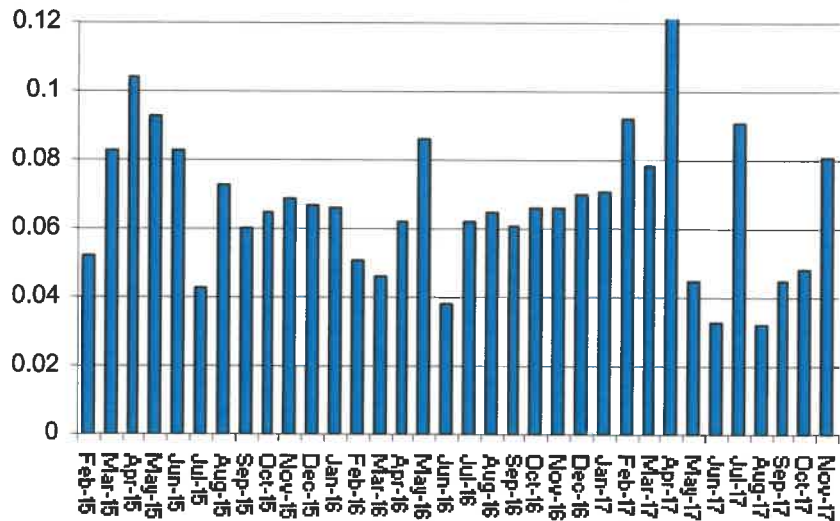
2015-2017 Phosphorus (mg/L)

The phosphorus concentration increased significantly to 0.081 mg/L as P. The total nitrogen concentration decreased to 0.70 mg/L as N. These data indicate that the lake had an overall increase in nutrients. Usually a nutrient increase results in an increase in algae growth. However, the phytoplankton data presented below indicate no significant change in the amount of algae. Cooler water temperatures and shorter hours of daylight likely influence the algae growth rate.

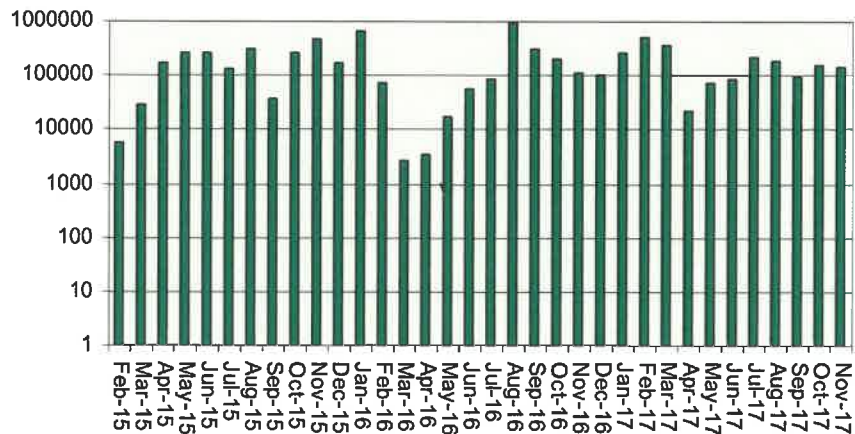
2015-2017 Algae Density (log-cells/mL)

The total algae density in the lake decreased slightly to 1.48×10^5 cells per mL, a density considered slightly elevated for an urban reservoir in metro-Phoenix. Blue-green (Cyanophyta) algae continued to comprise the majority of the algae population. The often problematic blue-green filament and colonies, *Oscillatoria* and *Microcystis*, remained. However, no significant algae issues were encountered.

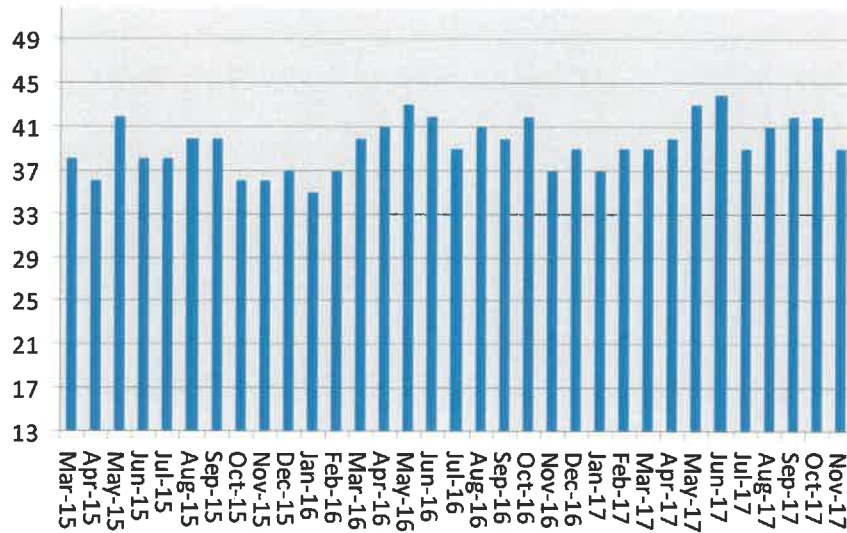
2015-2017 Report Card Scores

The water quality data are summarized on the attached Oasis Lake Report Card. Each salient parameter has been qualitatively evaluated and then assigned a numeric value for quantitative comparison and tracking purposes. The overall November rating (39) represents a decrease in water quality, but remains in the “good” category. The decrease was primarily due to the increase in phosphorus, turbidity, and bacteria.

Report card scores for the past two years are summarized below. Data indicate a similar variability in water quality scoring in 2015 and 2016, and a cyclic pattern.
