AQUATIC CONSULTING & TESTING, INC.

Ref: Oasis Lake, January 2019

The following report summarizes water quality data collected for Oasis Lake on 09 January 2019. Similar data have been reported each month and are used in this report to generate the graphs that are used for tracking changes in water quality. The report includes field data sheets summarizing weekly lake and mechanical system conditions during the month.

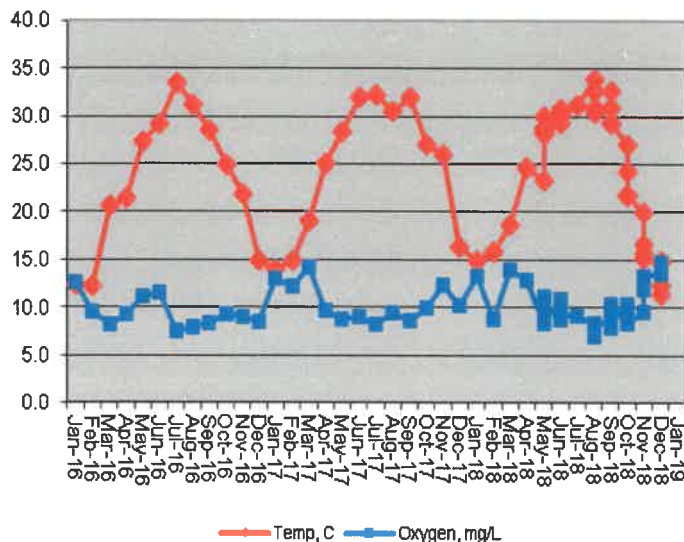
2016-2019 Temperature and Oxygen

Temperature, Oxygen, and pH: Water temperature decreased to 12.2 C (54 F) and the dissolved oxygen concentration was stable at 13.2 mg/L. At the time of sampling, the oxygen saturation was greater than 100 percent. Despite minor issues with portions of the aeration system, the operation of the floating fountains helped maintain dissolved oxygen at a level that was more than satisfactory for the fishery.

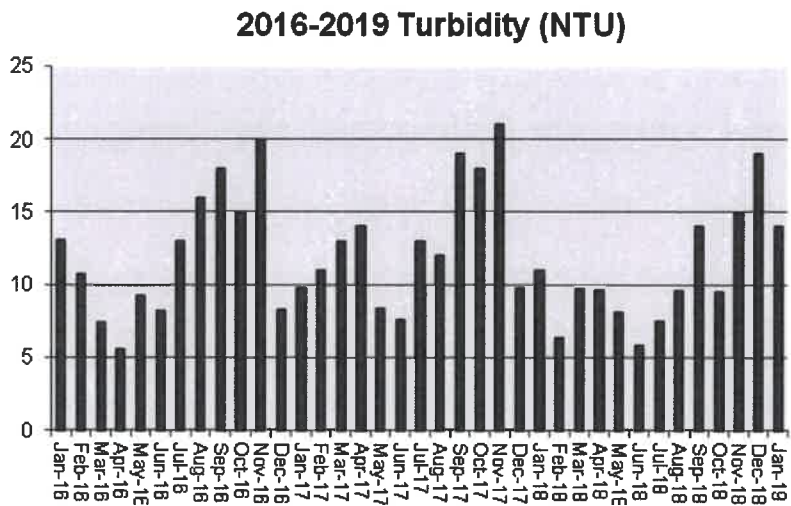
Turbidity: The turbidity of the lake water decreased to 14 NTU. The decrease has been attributed to reduced algae density. Water turbidity is impacted by dissolved and particulate matter in the water, including storm water runoff and dye that is periodically added for algae and weed management. As turbidity increases, clarity decreases.

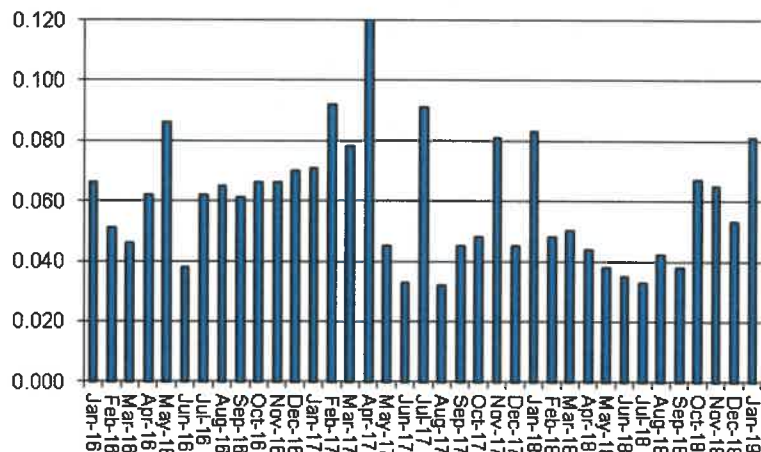
2016-2019 Phosphorus (mg/L)

The phosphorus concentration increased to 0.081 mg/L as P. The nitrogen concentration also increased to 1.50 mg/L as N. Usually a change in nutrient concentrations is reflected in changes in algae growth. In this case, an increase in algae density would typically be expected. However, the algae density decreased and the composition of the phytoplankton community changed (see below). Unusually cold weather may have limited growth.

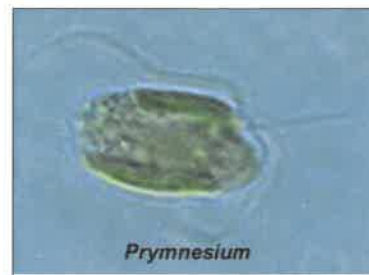
The total algae density in the lake decreased to 3.73×10^4 cells per mL, a density considered moderate for an urban reservoir in metro-Phoenix. The diatom (Bacillariophyta), *Achnanthes*, became the dominant form. Diatoms often become abundant during cold weather. Blue-green (Cyanophyta) algae comprised about 50 percent of the algal population. Many blue-green algae can become problematic in terms of producing floating mats and attached stringers, but no problems were encountered. The blue-green algae appear to be decreasing, resulting in reduced turbidity.

A one-half lake surface area algaecide application was made toward the end of the month to reduce increased algae growth that was detected about two weeks following the monthly sample collection (record is attached). Submerged weeds were not detected in the lake. Weeds have been controlled by stocking of the grass carp (White Amur, *Ctenopharyngodon idellus*) and by aquatic dye additions.

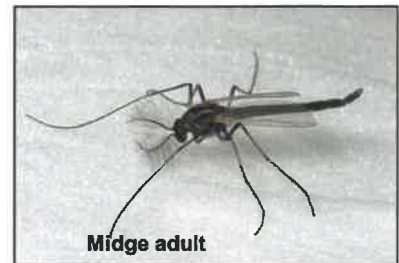
Midge flies: Midge flies are common inhabitants of most lakes. Adult females lay hundreds of eggs on the water surface. The eggs settle to the lake bottom and hatch in a few days. Larvae develop and grow in the superficial sediments over a three to four week period. In about 30 days the insect larvae become pupae, rise in the water column, and emerge as adult flies. The life cycle is shown diagrammatically at right. The Adults tend to swarm at dusk and dawn and

become a nuisance. They fly into residents' eyes and mouths, congregate under eaves of houses, and leave a sticky messy residue when they die. Management techniques may include stocking of bottom-feeding fishes to consume the larvae and/or application of bacterial or chemical larvicides. Because these fish have not been stocked for three years or more, a maintenance stocking of goldfish or sunfish is recommended.

Although water temperatures increased, few adult midge flies were detected during the month.

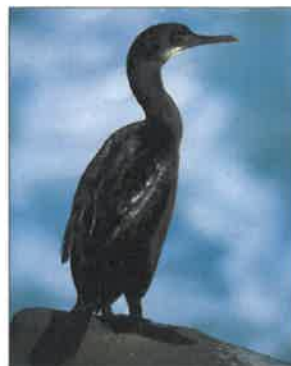
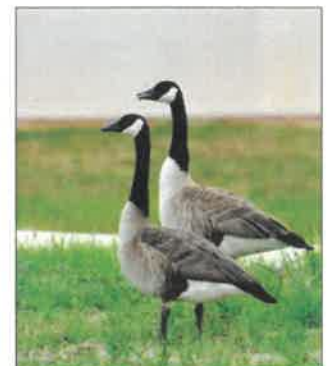
Based on the Arizona Game & Fish Department scale, the lake condition in terms of waterfowl has been in the "good to excellent" category from late summer through mid-winter. Cormorants were occasionally observed during the month and Canada geese appear to be increasing. Cormorants are diving birds that feed on small fish. Canada geese destroy turf and, along with other

birds, contribute fecal matter to the common areas and water.

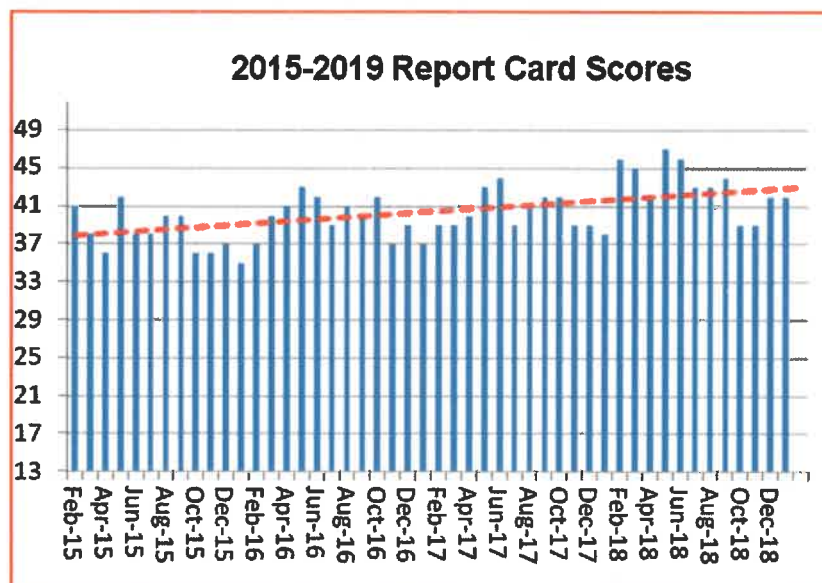
The water quality data are summarized on the attached Oasis Lake Report Card. Each salient parameter has been qualitatively evaluated and then assigned a numeric value for quantitative comparison and tracking purposes. The overall December score was 42, improved from the November value. Lower *E. coli* and phosphorus concentrations and lower pH were the primary reasons for the improvement in report card score.

Report card scores for the past three years are summarized above. Data still indicate a cyclic pattern and a long-term overall increasing trend in score, despite the recent decline.
