AQUATIC CONSULTING & TESTING, INC.

Ref: Oasis Lake, April 2019

The following report summarizes water quality data collected for Oasis Lake on 10 April 2019. Similar data have been reported each month and are used in this report to generate the graphs that are used for tracking changes in water quality. The report includes field data sheets summarizing weekly lake and mechanical system conditions during the month.

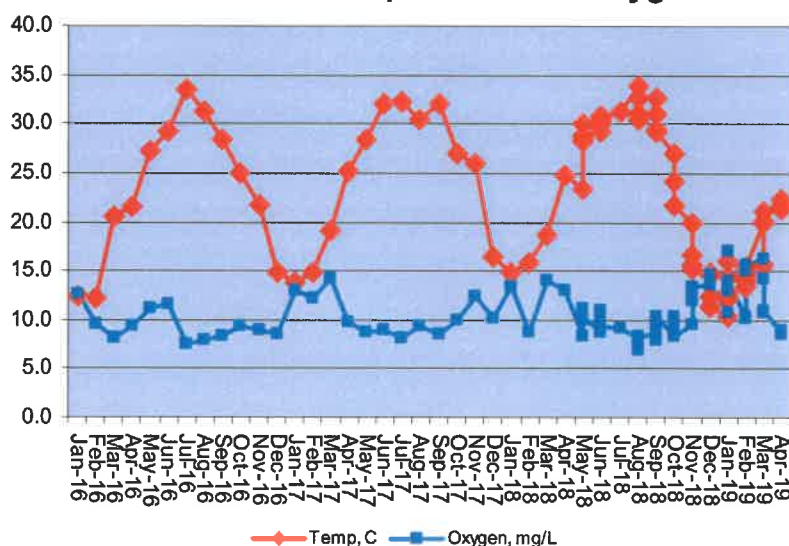
2016-2019 Temperature and Oxygen

Temperature, Oxygen, and pH: Water temperature increased to 21.7 C (71 F) and the dissolved oxygen concentration was at 100 percent saturation (8.8 mg/L). Despite issues with the aeration system, the operation of the floating fountains helped maintain dissolved oxygen at a level that was more than satisfactory for the fishery.

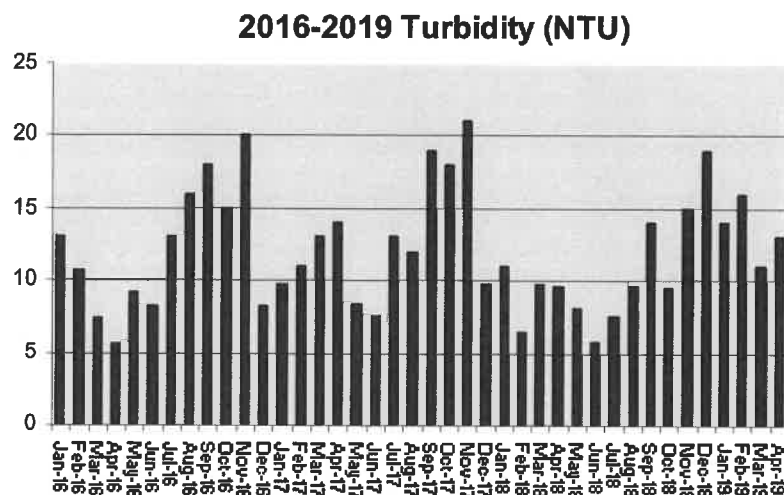
Turbidity: The turbidity of the lake water decreased to 11 NTU. The decrease is attributed to decreased algae density. Water turbidity is also impacted by dissolved and particulate matter in the water, including storm water runoff and dye that is periodically added for algae and weed management. As turbidity increases, clarity decreases.

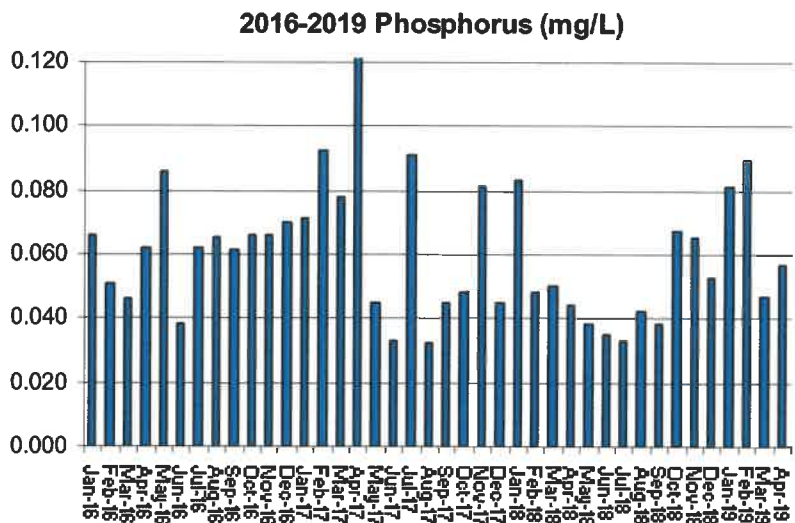
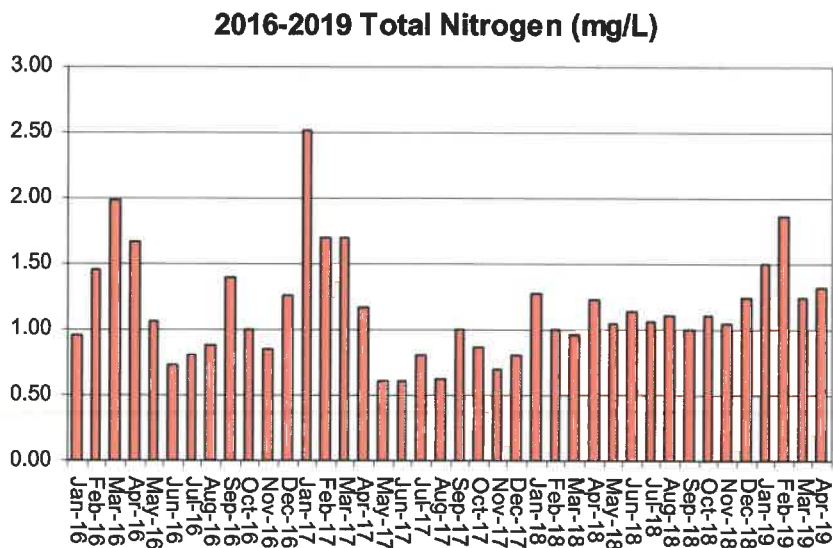
The phosphorus concentration decreased to 0.057 mg/L as P. The total nitrogen concentration also increased slightly to 1.32 mg/L as N. Nitrate, immediately available to algal cells, was at 0.12 mg/L. Usually a change in nutrient concentrations is reflected in changes in algae growth and density. In this case, a decrease in algae density did occur in response to decreased nutrient availability.

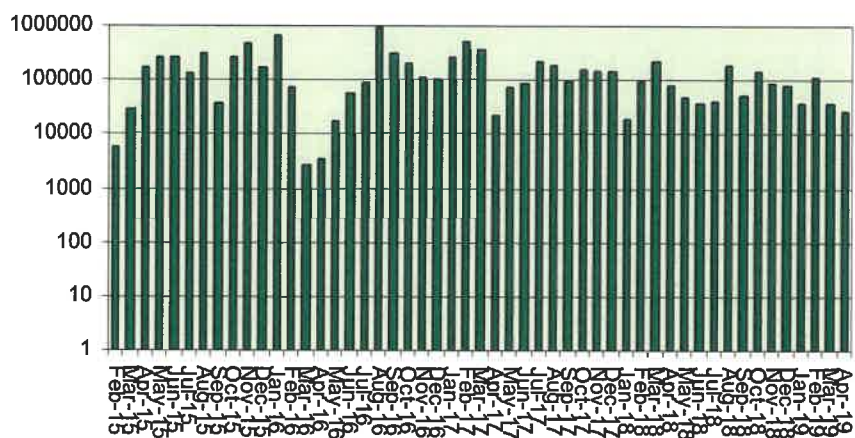
2016-2019 Algae Density (log-cells/mL)

The total algae density in the lake decreased to 2.69×10^4 cells per mL, a density considered moderate for an urban reservoir in metro-Phoenix. Diatoms (*Synedra*) returned as the dominant form. Blue-green filamentous algae were absent. Lake dye was added to reduce algae growth.

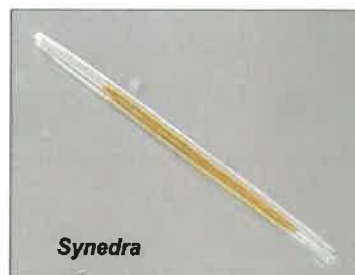
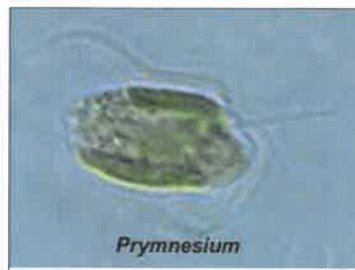
A test conducted on 18 April indicated presence of golden algae. The golden alga (*Prymnesium parvum*), produces toxins that rupture unprotected cells. The toxin release is believed to benefit golden algae by killing other species of algae, thereby making resources (nutrients) more available to the golden algae population. Unfortunately, the cells of fish gills are also unprotected because that is where oxygen absorption occurs. Thus, the toxin also results in asphyxiation of fish. Susceptibility to the toxin varies amongst fish species. An algaecide application was made on 23 April to reduce the toxic species. No fish mortalities were noted. Algaecide was also added to the entry water features to improve appearance.

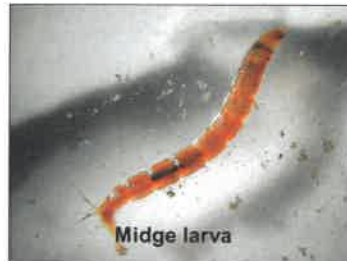
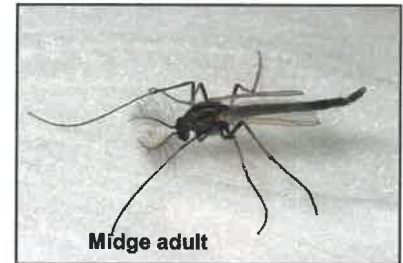
Midge flies: Midge flies are common inhabitants of most lakes. Adult females lay hundreds of eggs on the water surface. The eggs settle to the lake bottom and hatch in a few days. Larvae develop and grow in the superficial sediments over a three to four week period. In about 30 days the insect larvae become pupae, rise in the water column, and emerge as adult flies. The

life cycle is shown diagrammatically below. Adults tend to swarm at dusk and dawn and become a nuisance. They fly into residents' eyes and mouths, congregate under eaves of houses, and leave a sticky messy residue when they die. Management techniques may include stocking of bottom-feeding fishes to consume the larvae and/or application of bacterial or chemical larvicides. Because these fish have not been stocked for three years or more, a maintenance stocking of goldfish or sunfish is recommended.

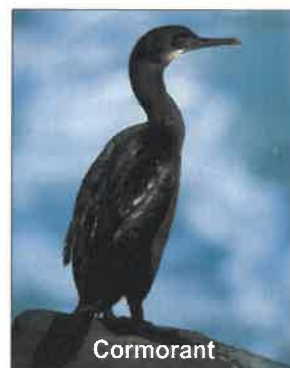
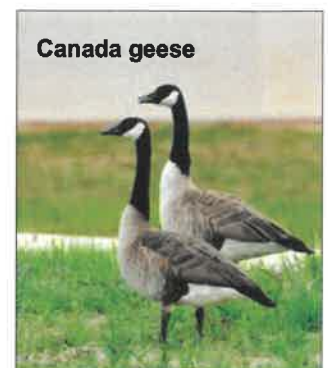
Based on the Arizona Game & Fish Department scale, the lake condition in terms of waterfowl has been in the "good to excellent" category from late summer through mid-winter. Cormorants were rarely observed during the month and Canada geese numbers appear to be approaching zero.

Cormorants are diving birds that feed on small fish. Canada geese destroy turf and, along with other birds, contribute fecal matter to the common areas and water.

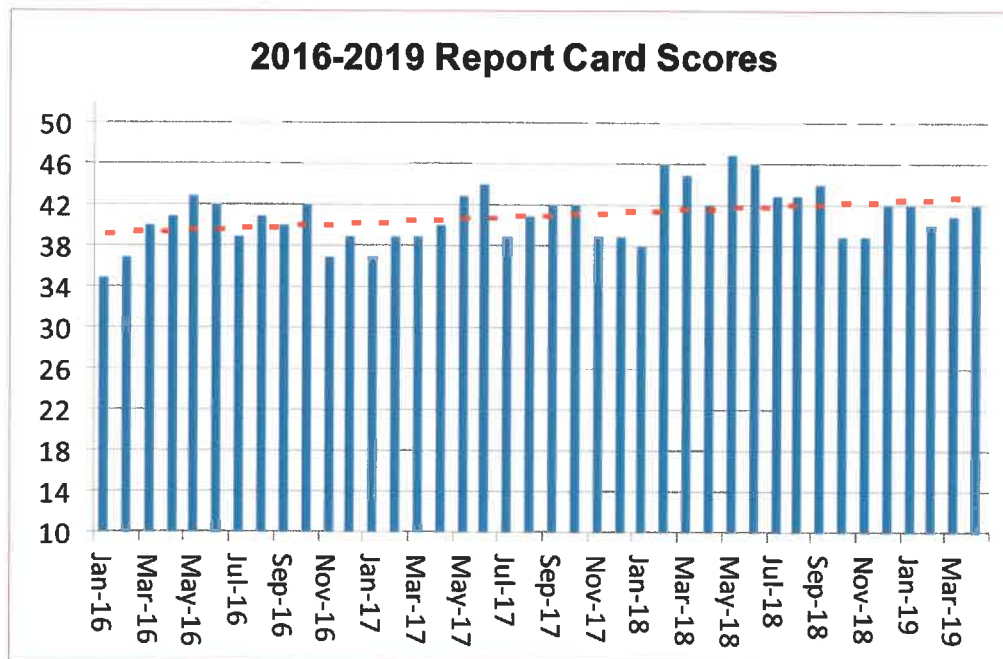
The water quality data are summarized on the attached Oasis Lake Report Card. Each salient parameter has been qualitatively evaluated and then assigned a numeric value for quantitative comparison and tracking purposes. The April score was 42, a small increase from the score of 41 for March 2019. Decreased algae density, especially blue-greens, was the primary reason for the higher report card score.

Report card scores for the past three years have been graphically summarized above. Data still indicate a somewhat cyclic pattern and a long-term overall increasing trend in score.
