AQUATIC CONSULTING & TESTING, INC.

Ref: Oasis Lake, May 2019

The following report summarizes water quality data collected for Oasis Lake on 08 May 2019. Similar data have been reported each month and are used in this report to generate the graphs that are used for tracking changes in water quality. The report includes field data sheets summarizing weekly lake and mechanical system conditions during the month.

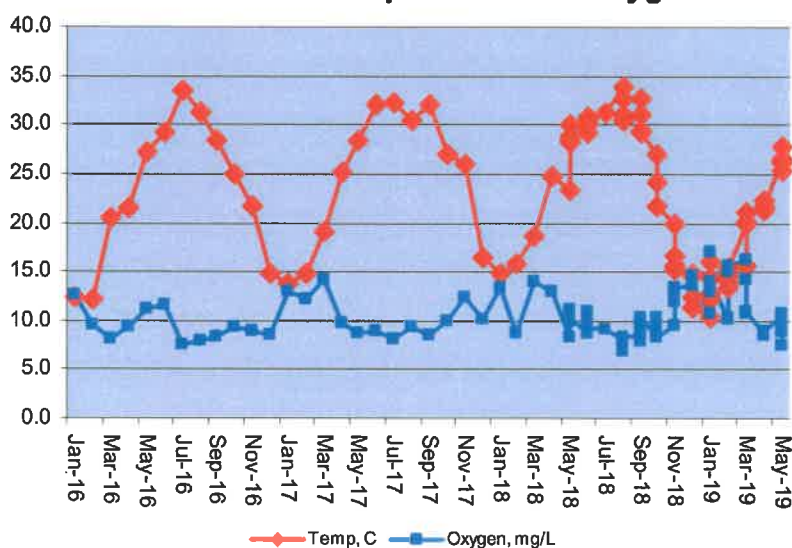
2016-2019 Temperature and Oxygen

Temperature, Oxygen, and pH: Water temperature increased to 25.3 C (78 F) and the dissolved oxygen concentration was over 100 percent saturation (8.3 mg/L). Despite issues with the aeration system, the operation of the floating fountains helped maintain dissolved oxygen at a level that was more than satisfactory for the fishery.

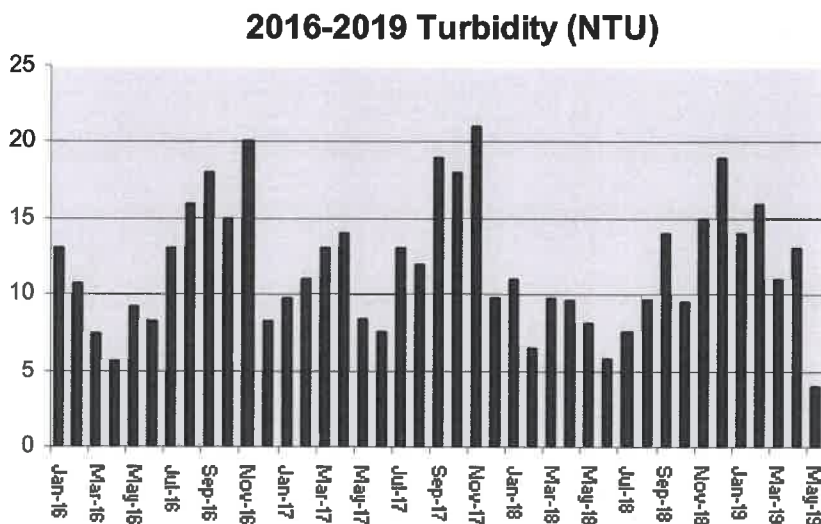
Turbidity: The turbidity of the lake water continued to decrease (4.0 NTU). The decrease is attributed to decreased algae density. Water turbidity is also impacted by dissolved and particulate matter in the water, including storm water runoff and dye that is periodically added for algae and weed management. As turbidity increases, clarity decreases.

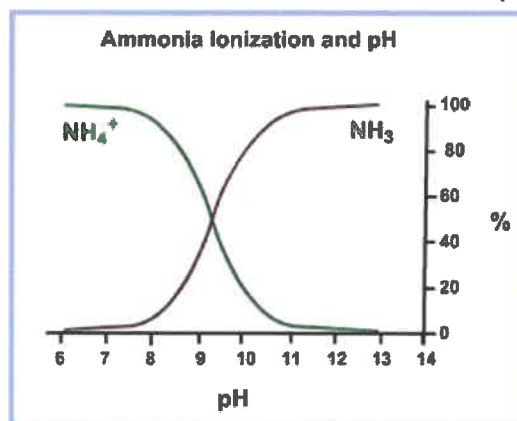
pH: The lake water pH steadily increased during the month, ranging from 8.3 to 9.0 SU. Water pH is influenced by the chemical makeup of the water and the amount of algae in the lake. In a very simplified explanation for the role of algae, carbonic acid in the water is formed from dissolution of carbon dioxide. Carbonic acid tends to make the water more acidic and pH decreases. However, algae utilize carbon dioxide during photosynthesis during daylight, making less carbon dioxide available to form carbonic acid, and pH increases. The more algae present, the greater the increase in pH that usually occurs. Data indicate that increasing water temperatures supported additional algae growth through the end of the month.

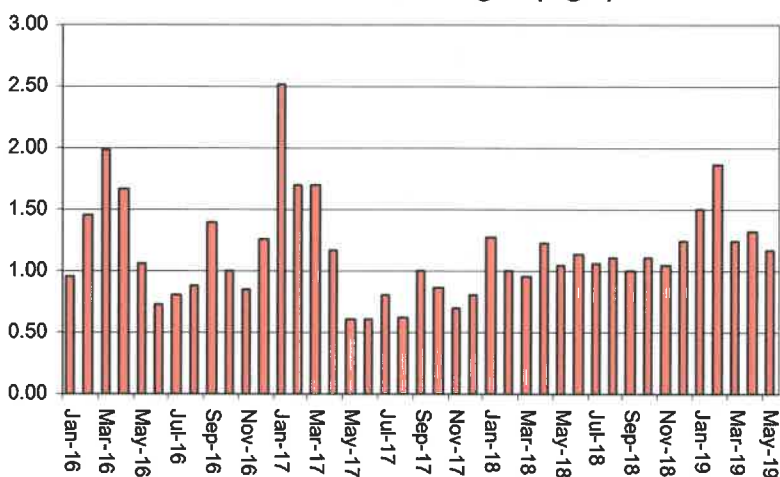
2016-2019 Total Nitrogen (mg/L)

The phosphorus concentration decreased to 0.020 mg/L as P. The total nitrogen concentration also decreased slightly to 1.16 mg/L as N. Nitrate, immediately available to algal cells, was at a concentration of 0.06 mg/L. Usually a change in nutrient concentrations is reflected in changes in algae growth and density. In this case, a decrease in algae density did occur at the time of sampling in response to decreased nutrient availability.

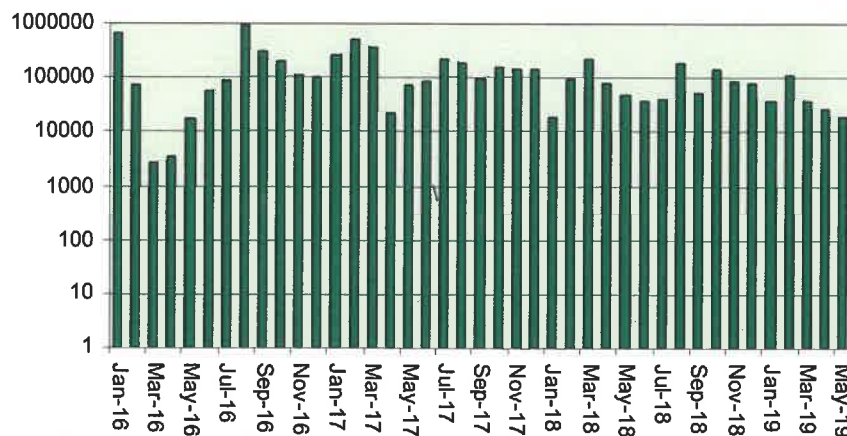
2016-2019 Algae Density (log-cells/mL)

The total algae density in the lake decreased slightly to 1.83×10^4 cells per mL, a density considered moderate for an urban reservoir in metro-Phoenix. Green colonial algae (*Scenedesmus*) became the dominant form. Problematic blue-green filamentous algae were absent. Lake dye was added during the month to reduce algae growth.

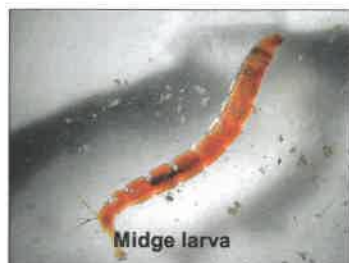
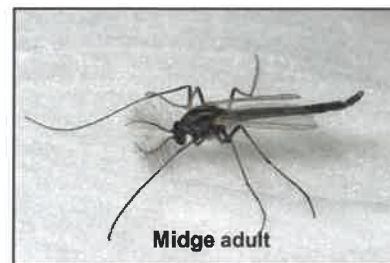
Midge flies: Midge flies are common inhabitants of most lakes. Adult females lay hundreds of eggs on the water surface. The eggs settle to the lake bottom and hatch in a few days. Larvae develop and grow in the superficial sediments over a three to four week period. In about 30 days the insect larvae become pupae, rise in the water column, and emerge as adult flies. The life cycle is shown diagrammatically below. Adults tend to swarm at dusk and dawn and

Although water temperatures increased, few adult midge flies were detected during the month.

become a nuisance. They fly into residents' eyes and mouths, congregate under eaves of houses, and leave a sticky messy residue when they die. Management techniques may include stocking of bottom-feeding fishes to consume the larvae and/or application of bacterial or chemical larvicides. Because these fish have not been stocked for three years or more, a maintenance stocking of goldfish or sunfish is recommended.

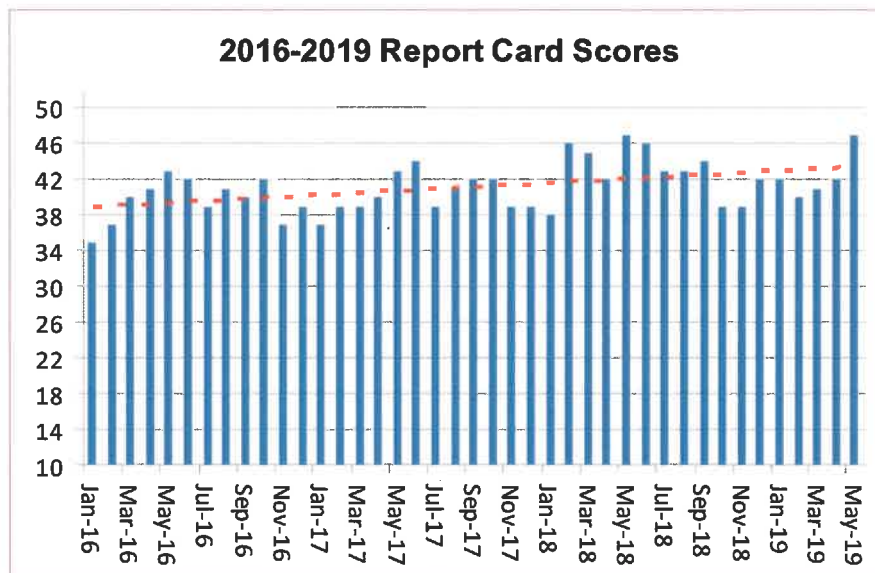
The water quality data are summarized on the attached Oasis Lake Report Card. Each salient parameter has been qualitatively evaluated and then assigned a numeric value for quantitative comparison and tracking purposes. The May score was 47, a significant increase compared to the score of 42 for April 2019. Decreased phosphorus concentration and turbidity, along with the change in algae composition were the primary reasons for the higher report card score.

Report card scores for the past three years have been graphically summarized above. Data still indicate a somewhat cyclic pattern and a long-term overall increasing trend in score.
