AQUATIC CONSULTING & TESTING, INC.

Ref: Oasis Lake, June 2019

The following report summarizes water quality data collected for Oasis Lake on 05 June 2019. Similar data have been reported each month and are used in this report to generate the graphs that are used for tracking changes in water quality. The report includes field data sheets summarizing weekly lake and mechanical system conditions during the month.

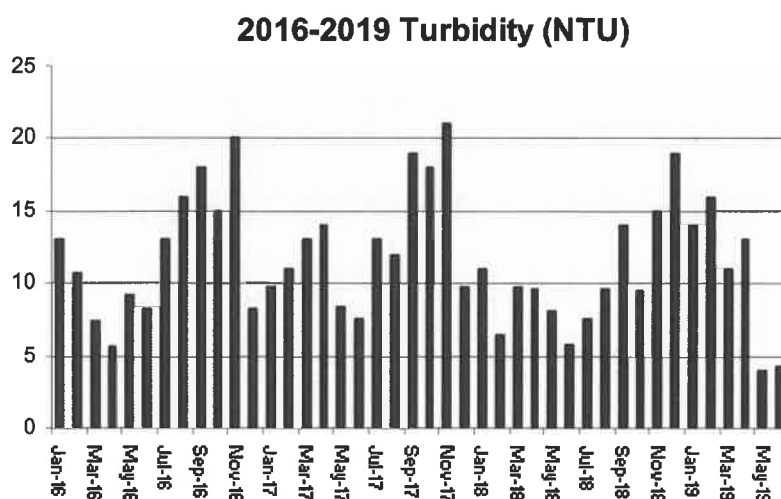
Turbidity: The turbidity of the lake water increased slightly (4.2 NTU), despite the algal density continuing to decrease. Water turbidity is also impacted by dissolved and particulate matter in the water, including storm water runoff and dye that is periodically added for algae and weed management. As turbidity increases, clarity decreases.

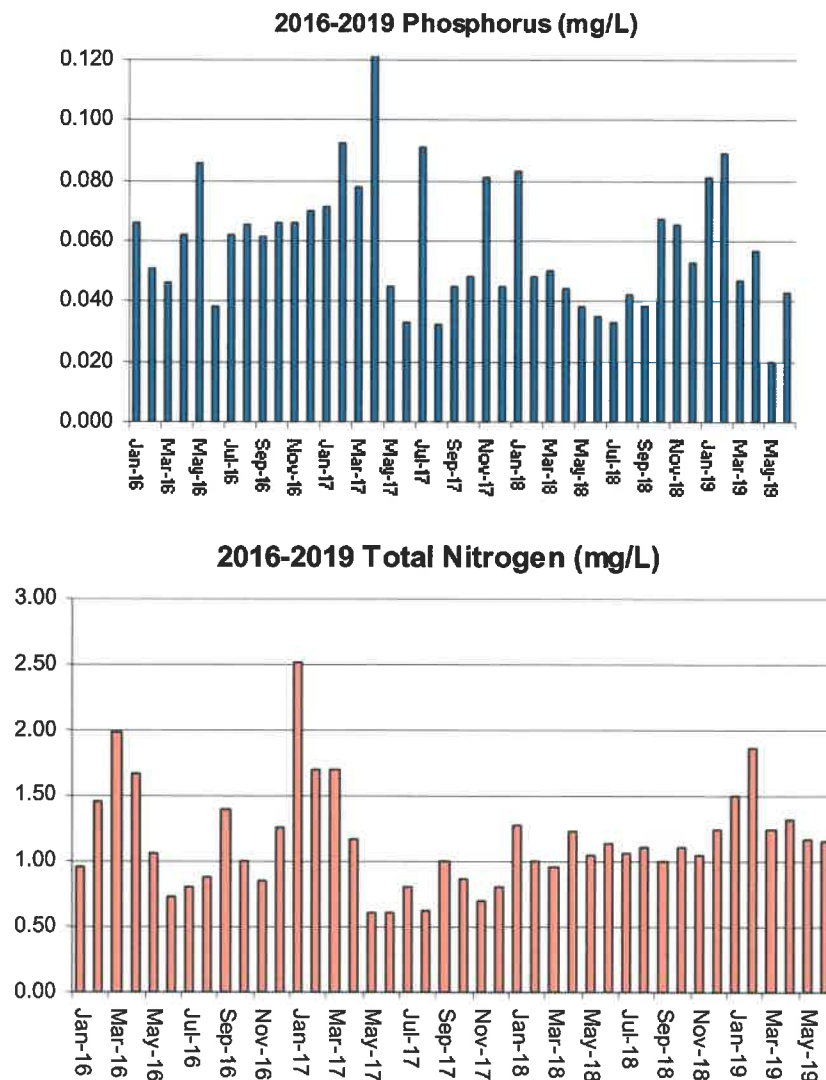
The phosphorus concentration increased to 0.043 mg/L as P. The total nitrogen concentration also decreased slightly to 1.15 mg/L as N. Nitrate, immediately available to algal cells, was at a concentration of <0.05 mg/L. Usually a change in nutrient concentrations is reflected in changes in algae growth and density. In this case, a decrease in algae density did occur at the time of sampling in response to decreased nitrogen availability.
