AQUATIC CONSULTING & TESTING, INC.

Ref: Oasis Lake, June 2020

The following report summarizes water quality data collected for Oasis Lake on 03 June 2020. Similar data have been reported each month and are used in this report to generate the graphs that are used for tracking changes in water quality. The report includes field data sheets summarizing weekly lake and mechanical system conditions during the month.

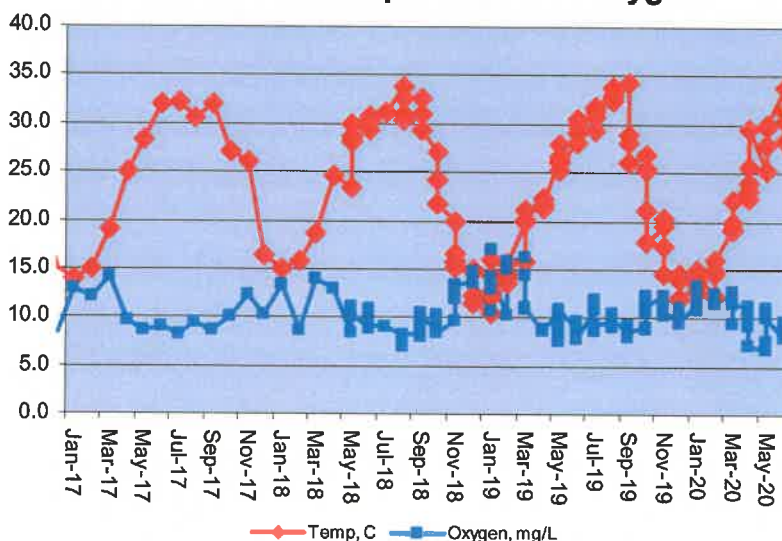
2017-2020 Temperature and Oxygen

Temperature, Oxygen, and pH: Water temperature increased to 33.8 C (93 F) and the dissolved oxygen concentration was over 100 percent saturation (7.9 mg/L). Operation of the floating fountains, as well as the trial nanobubble oxygenation system, helped maintain dissolved oxygen at a level that was satisfactory for the fishery.

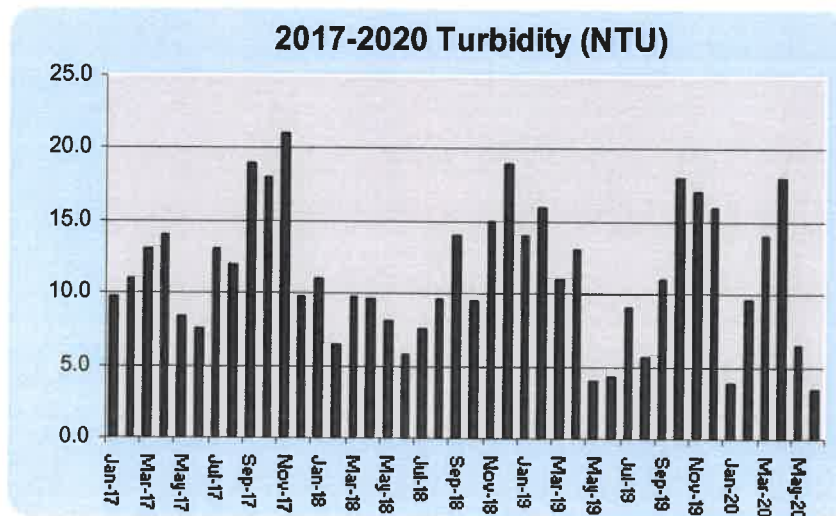
Turbidity: The turbidity of the lake water continued to decrease (3.5 NTU). Water turbidity is impacted by algae density and dissolved and particulate matter in the water, including storm water runoff and dye that is periodically added for algae and weed management. As turbidity increases, clarity decreases. The trend shows continued improvement in lake clarity.

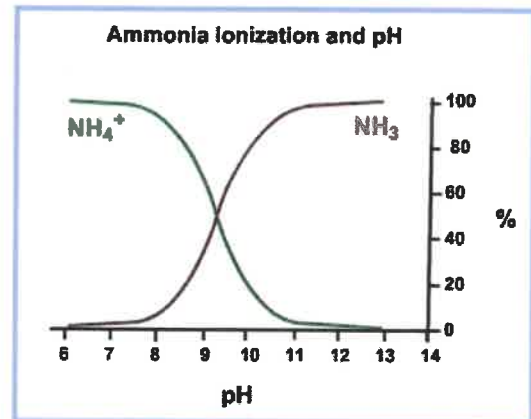
pH: The lake water pH varied, as typical, from 8.7 to 9.2 SU during the month. Water pH is influenced by the chemical makeup of the water and the amount of algae in the lake. In a very simplified explanation for the role of algae, carbonic acid in the water is formed from dissolution of carbon dioxide. Carbonic acid tends to make the water more acidic and pH decreases. However, algae utilize carbon dioxide during photosynthesis during daylight, making less carbon dioxide available to form carbonic acid, and pH increases. The more algae present, the greater the increase in pH that usually occurs. Data indicate that pH was similar to measurements last month. pH changes may also result from differences in SRP canal feed water composition.

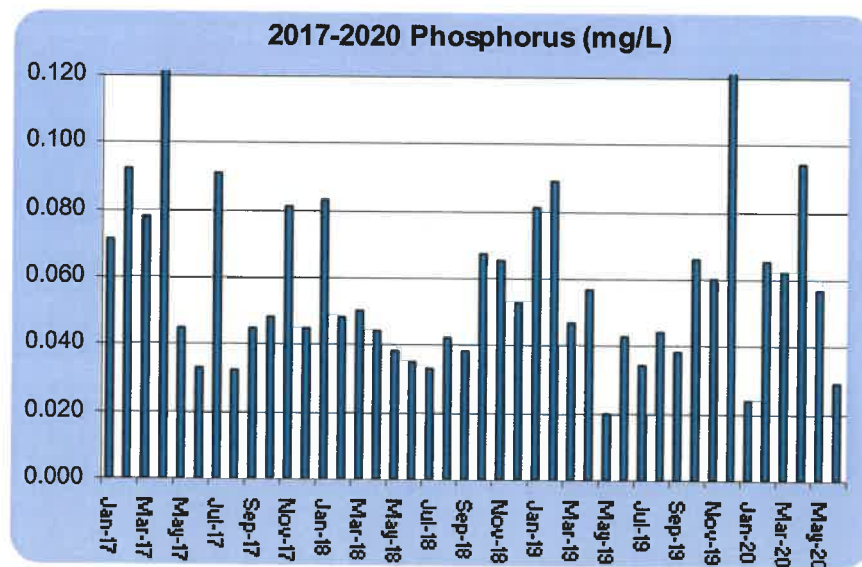
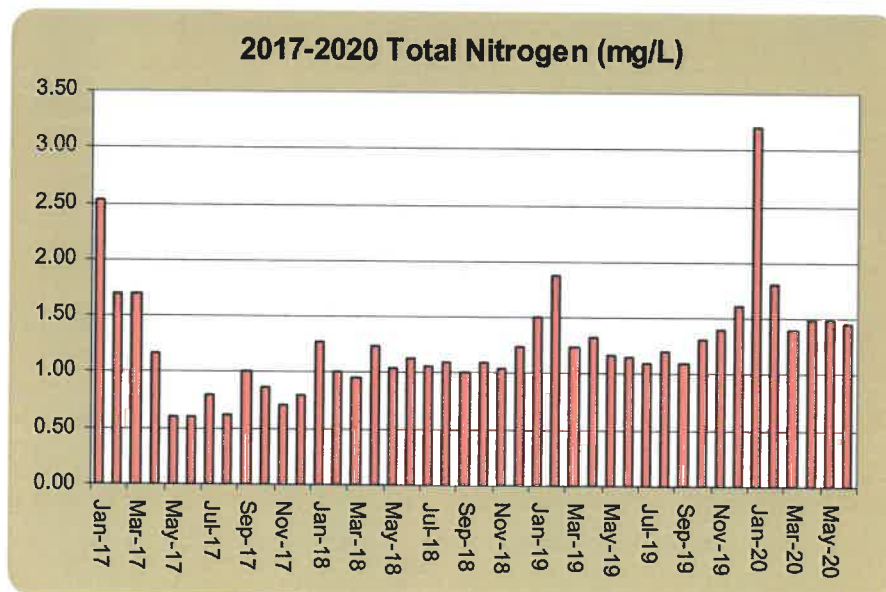
The phosphorus concentration continued to decrease (0.029) mg/L as P. The total nitrogen concentration was stable at 1.45 mg/L as N. Nitrate, immediately available to algal cells, was at a low concentration of 0.05 mg/L. A decrease in nutrient concentrations was evident and a corresponding decrease in algae growth would be expected and occurred.

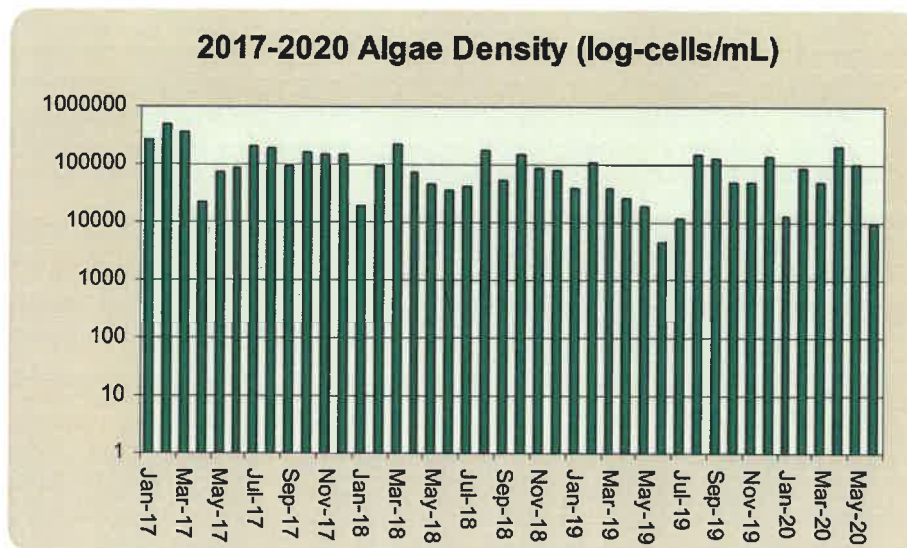
As predicted, the total algae density in the lake decreased to 8.94×10^3 cells per mL, a density considered low to moderate for an urban reservoir in metro-Phoenix. Often-problematic blue-green (Cyanophyta) algae (*Oscillatoria*, *Chroococcus*) comprised about 32 percent of the total assemblage. The dominant alga was again, *Chlorella*, a generally benign green (Chlorophyta) unicell.

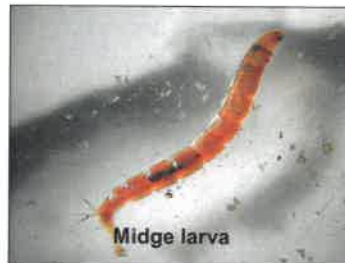
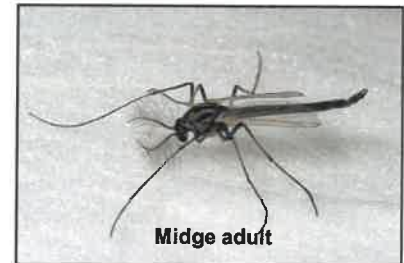
Midge flies: Midge flies are common inhabitants of most lakes. Adult females lay hundreds of eggs on the water surface. The eggs settle to the lake bottom and hatch in a few days. Larvae develop and grow in the superficial sediments over a three to four week period. In about 30 days the insect larvae become pupae, rise in the water column, and emerge as adult flies. The life cycle is shown diagrammatically below. Adults tend to swarm at dusk and dawn and become a nuisance. They fly into residents' eyes and mouths, congregate under eaves of houses, and leave a sticky messy residue when they die. Management techniques may include stocking of bottom-feeding fishes to consume the larvae and/or application of bacterial or chemical larvicides. Because fish have not been stocked for three years or more, a maintenance stocking proposal has been presented to the Board. Action has been delayed because of golden algae and lake wall repairs.

Few adult midge flies were detected during the month.

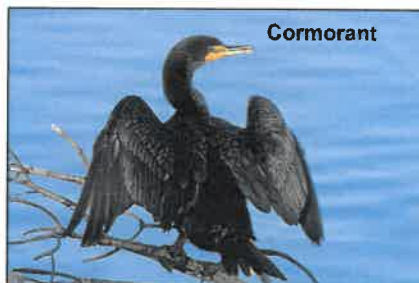
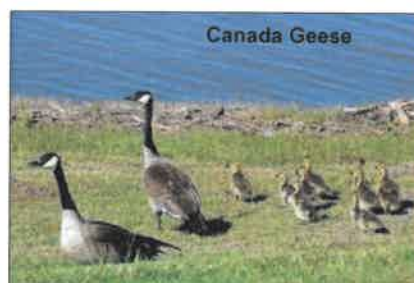
Problematic Canada geese were observed during the month. Canada geese can destroy turf and, along with other birds, contribute fecal matter to the common areas and water. Cormorants, diving birds that feed on small fish, were not seen. See photos above.

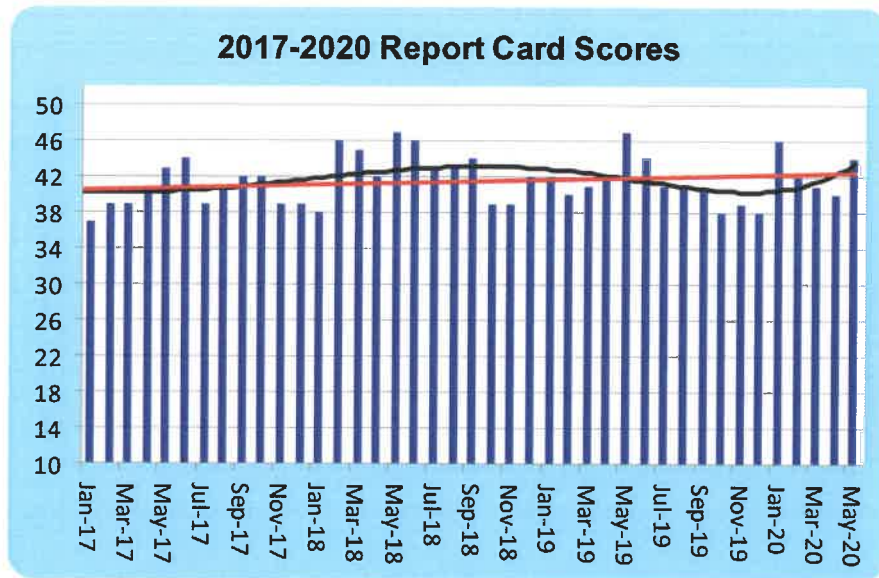
Report card scores for the past three years have been graphically summarized below. Polynomial regression analysis (black line) still indicates a somewhat cyclic pattern. Linear regression analysis (red line) indicates an overall increasing trend in score.
