AQUATIC CONSULTING & TESTING, INC.

Ref: **Oasis Lake, August 2019**

The following report summarizes water quality data collected for Oasis Lake on 07 August 2019. Similar data have been reported each month and are used in this report to generate the graphs that are used for tracking changes in water quality. The report includes field data sheets summarizing weekly lake and mechanical system conditions during the month.

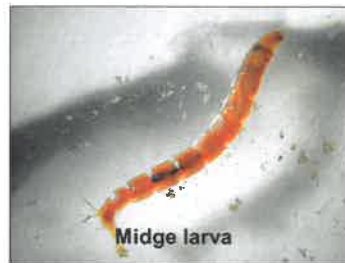
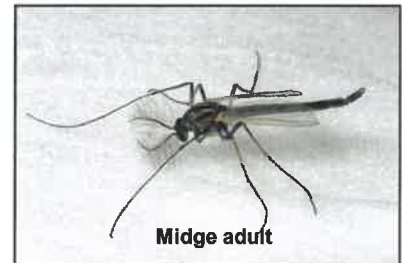
Midge flies: Midge flies are common inhabitants of most lakes. Adult females lay hundreds of eggs on the water surface. The eggs settle to the lake bottom and hatch in a few days. Larvae develop and grow in the superficial sediments over a three to four week period. In about 30 days the insect larvae become pupae, rise in the water column, and emerge as adult flies. The life cycle is shown diagrammatically below. Adults tend to swarm at dusk and dawn and become a nuisance. They fly into residents' eyes and mouths, congregate under eaves of houses, and leave a sticky messy residue when they die. Management techniques may include stocking of bottom-feeding fishes to consume the larvae and/or application of bacterial or chemical larvicides. Because these fish have not been stocked for three years or more, a maintenance stocking of goldfish or sunfish is recommended for spring 2020.

Although water temperatures increased, few adult midge flies were detected during the month.

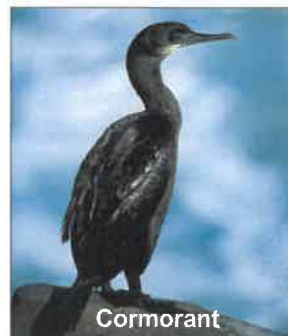
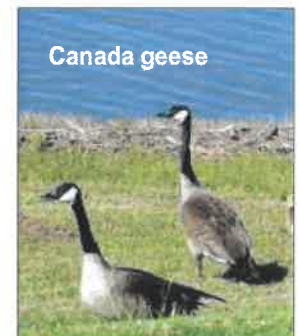
Based on the Arizona Game & Fish Department scale, the lake condition in terms of waterfowl has been in the "excellent" category. Cormorants and Canada geese were rarely observed during the month. Cormorants are diving birds that feed on small fish.

Canada geese destroy turf and, along with other birds, contribute fecal matter to the common areas and water.
