AQUATIC CONSULTING & TESTING, INC.

Ref: Oasis Lake, November 2019

The following report summarizes water quality data collected for Oasis Lake on 06 November 2019. Similar data have been reported each month and are used in this report to generate the graphs that are used for tracking changes in water quality. The report includes field data sheets summarizing weekly lake and mechanical system conditions during the month.

LABORATORY REPORT

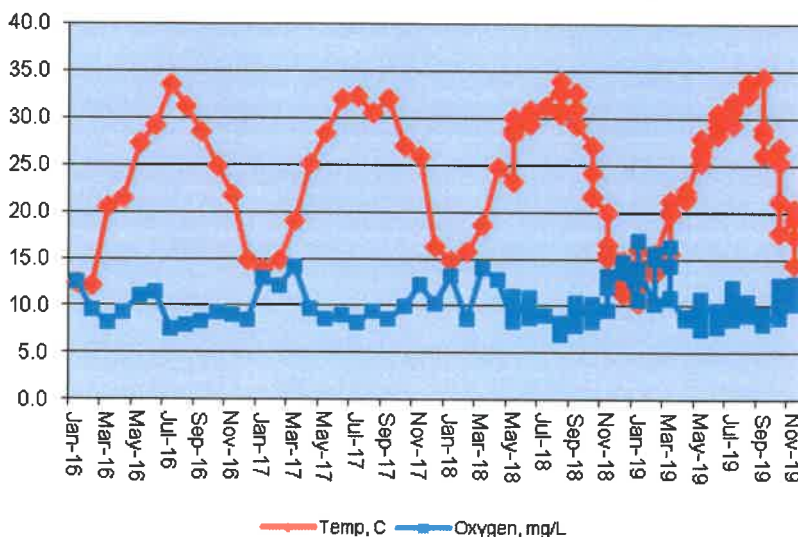
2016-2019 Temperature and Oxygen

Temperature, Oxygen, and pH: Water temperature was stable at 19.4 C (67 F) and the dissolved oxygen concentration remained over 100 percent saturation (12.4 mg/L). Operation of the floating fountains, as well as the trial nanobubble oxygenation system, helped maintain dissolved oxygen at a level that was more than satisfactory for the fishery.

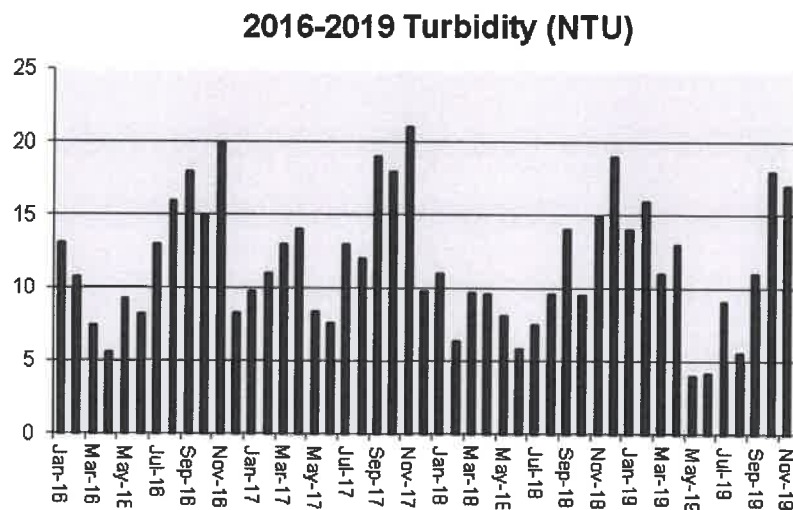
Turbidity: The turbidity of the lake water was essentially unchanged at 17 NTU. Water turbidity is impacted by algae density and dissolved and particulate matter in the water, including storm water runoff and dye that is periodically added for algae and weed management. As turbidity increases, clarity decreases.

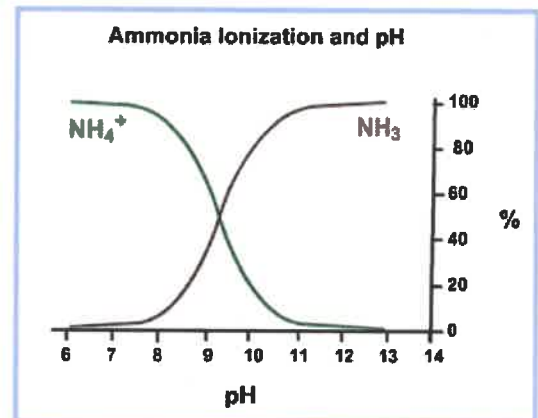
pH: The lake water pH varied from 8.2 to 8.9 SU during the month. Water pH is influenced by the chemical makeup of the water and the amount of algae in the lake. In a very simplified explanation for the role of algae, carbonic acid in the water is formed from dissolution of carbon dioxide. Carbonic acid tends to make the water more acidic and pH decreases. However, algae utilize carbon dioxide during photosynthesis during daylight, making less carbon dioxide available to form carbonic acid, and pH increases. The more algae present, the greater the increase in pH that usually occurs. Data indicate that pH decreased very slightly as water temperatures and algae density did not change appreciably from that measured last month. pH changes may also result from differences in SRP canal feed water composition.

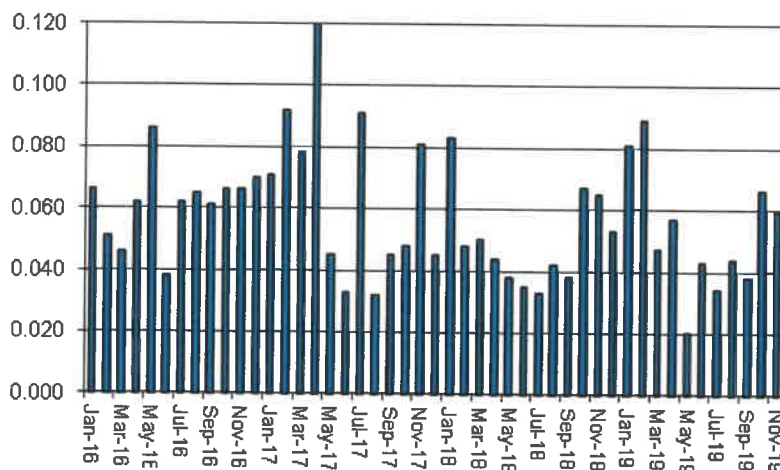
2016-2019 Phosphorus (mg/L)

The phosphorus concentration decreased slightly to 0.060 mg/L as P. The total nitrogen concentration increased slightly to 1.40 mg/L as N. Nitrate, immediately available to algal cells, was at a concentration of <0.05 mg/L. Usually a change in nutrient concentrations is reflected in changes in algae growth and density. Because there was little change in nutrient concentrations, little change in algae response would be expected.

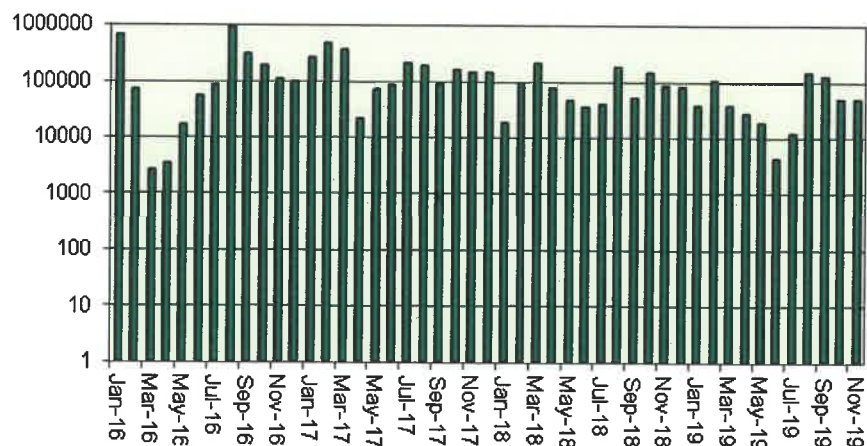
2016-2019 Algae Density (log-cells/mL)

As predicted, the total algae density in the lake was essentially unchanged at 4.99×10^4 cells per mL, a density considered moderate for an urban reservoir in metro-Phoenix. Blue-green (Cyanophyta) filamentous and colonial algae, *Oscillatoria* and *Chroococcus*, respectively, were the dominant forms. *Oscillatoria* can form stringers along the lake edge, bottom growths, or floating mats. However, only minor edge growth was observed. *Chroococcus* typically turns the water color to olive green.

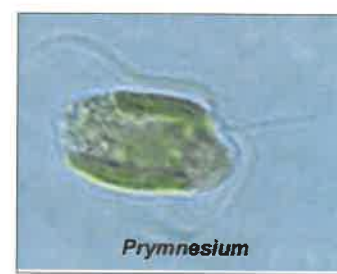
Tests conducted through the month indicated no presence of golden algae. Golden algae have been identified in six lake systems in metro-Phoenix so far this season. The golden alga (*P.*

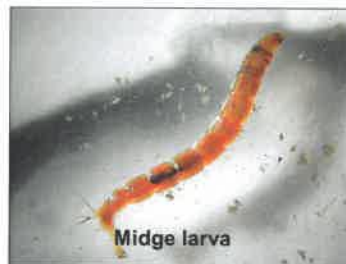
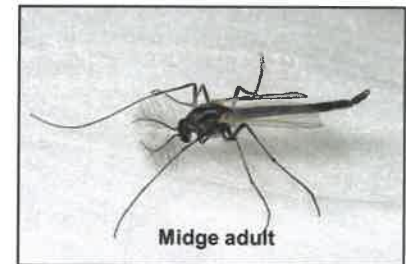
Few adult midge flies were detected during the month.

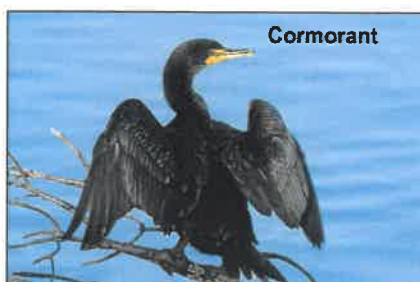
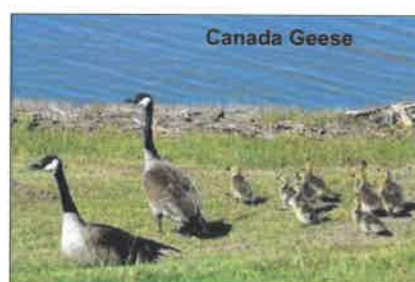
Cormorants and Canada geese were rarely observed during the month. Cormorants are diving birds that feed on small fish. Canada geese destroy turf and, along with other birds, contribute fecal matter to the common areas and water. See photos above.

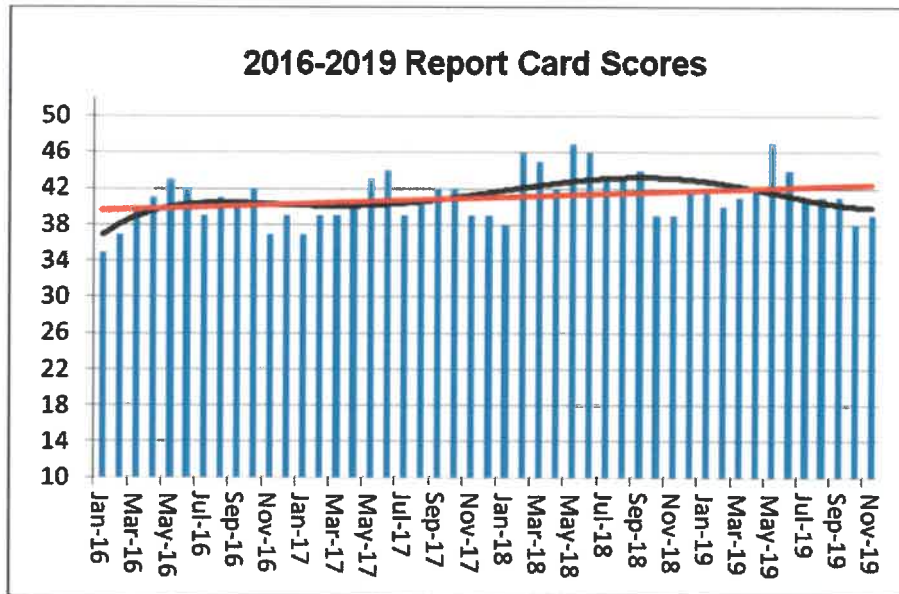
Report card scores for the past three years have been graphically summarized below. Polynomial regression analysis (black line) still indicates a somewhat cyclic pattern. Linear regression analysis (red line) indicates an overall increasing trend in score.
