# AQUATIC CONSULTING & TESTING, INC.

Ref: **Oasis Lake, December 2019**

The following report summarizes water quality data collected for Oasis Lake on 04 December 2019. Similar data have been reported each month and are used in this report to generate the graphs that are used for tracking changes in water quality. The report includes field data sheets summarizing weekly lake and mechanical system conditions during the month.

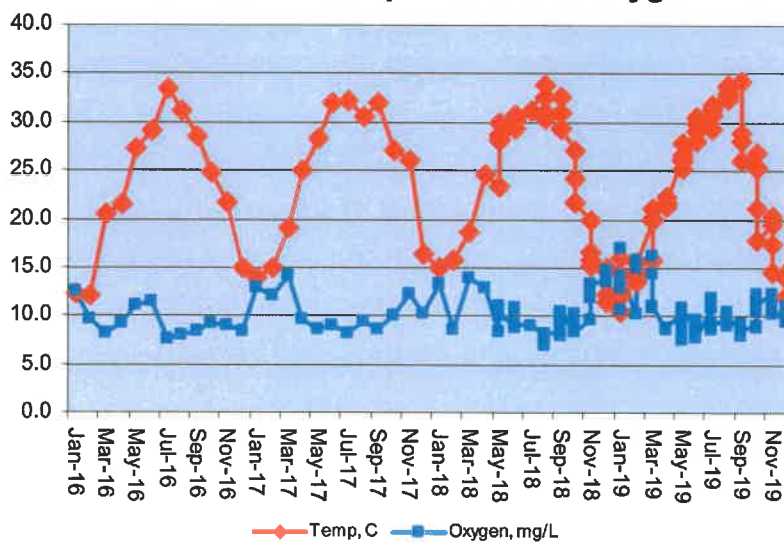
**2016-2019 Temperature and Oxygen**

**Temperature, Oxygen, and pH:** Water temperature decreased to 13.9 C (57 F) and the dissolved oxygen concentration was at 92 percent saturation (9.5 mg/L). Operation of the floating fountains, as well as the trial nanobubble oxygenation system, helped maintain dissolved oxygen at a level that was more than satisfactory for the fishery.

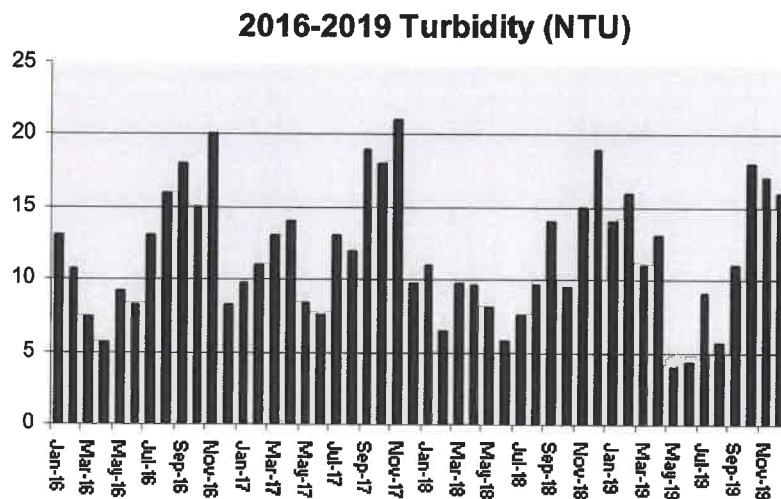
**Turbidity:** The turbidity of the lake water was essentially unchanged at 16 NTU, although a slow reduction is apparent. Water turbidity is impacted by algae density and dissolved and particulate matter in the water, including storm water runoff and dye that is periodically added for algae and weed management. As turbidity increases, clarity decreases.

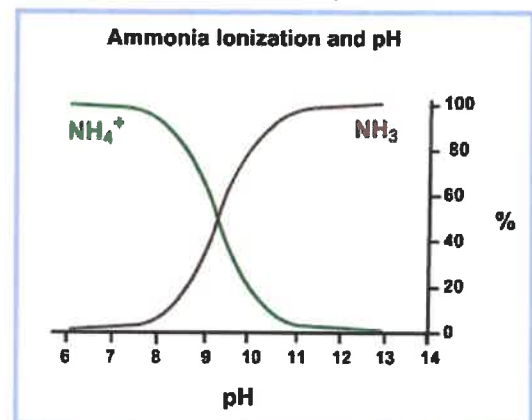
**pH:** The lake water pH varied from 8.5 to 8.7 SU during the month. Water pH is influenced by the chemical makeup of the water and the amount of algae in the lake. In a very simplified explanation for the role of algae, carbonic acid in the water is formed from dissolution of carbon dioxide. Carbonic acid tends to make the water more acidic and pH decreases. However, algae utilize carbon dioxide during photosynthesis during daylight, making less carbon dioxide available to form carbonic acid, and pH increases. The more algae present, the greater the increase in pH that usually occurs. Data indicate that pH decreased slightly as water temperatures and algae density decreased compared to measurements last month. pH changes may also result from differences in SRP canal feed water composition.

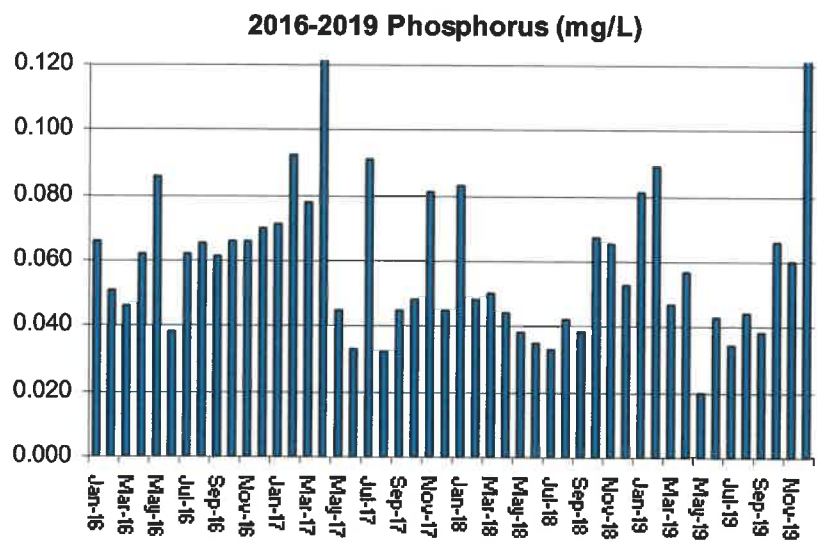
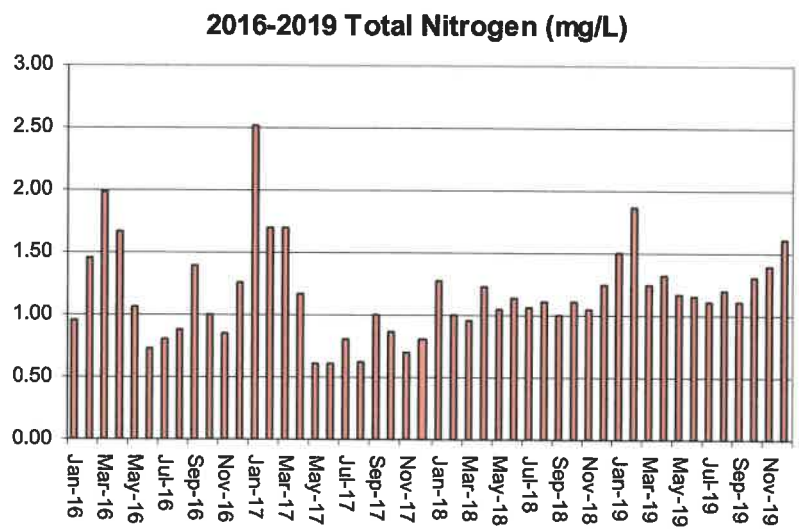
The phosphorus concentration doubled compared to last month (0.124 mg/L as P). Cause may be the source water, storm water runoff, or fertilizer runoff. The total nitrogen concentration increased slightly to 1.60 mg/L as N. Nitrate, immediately available to algal cells, was at a concentration of <0.05 mg/L. Usually a change in nutrient concentrations is reflected in changes in algae growth and density. Because there was a significant change in phosphorus concentration, a change in algae response would be expected and occurred.

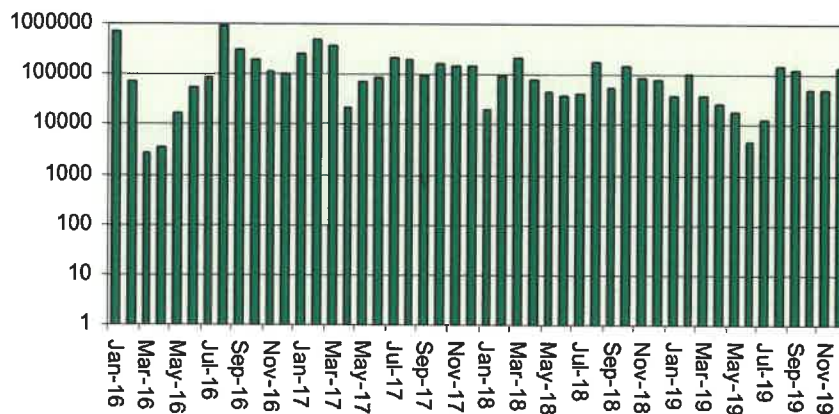
**2016-2019 Algae Density (log-cells/mL)**

As predicted, the total algae density in the lake increased to  $1.36 \times 10^5$  cells per mL, a density considered slightly elevated for an urban reservoir in metro-Phoenix. Blue-green (Cyanophyta) filamentous and colonial algae, *Oscillatoria* and *Microcystis*, respectively, were the dominant forms. *Oscillatoria* can form stringers along the lake edge, bottom growths, or floating mats. However, only minor edge growth was observed. *Microcystis* can form downwind floating masses, but this was not observed.

Lake dye was added during the month because a reduction in algae growth was not apparent despite cooler water temperatures and no sign of golden algae (*Prymnesium parvum* and related species) was identified.

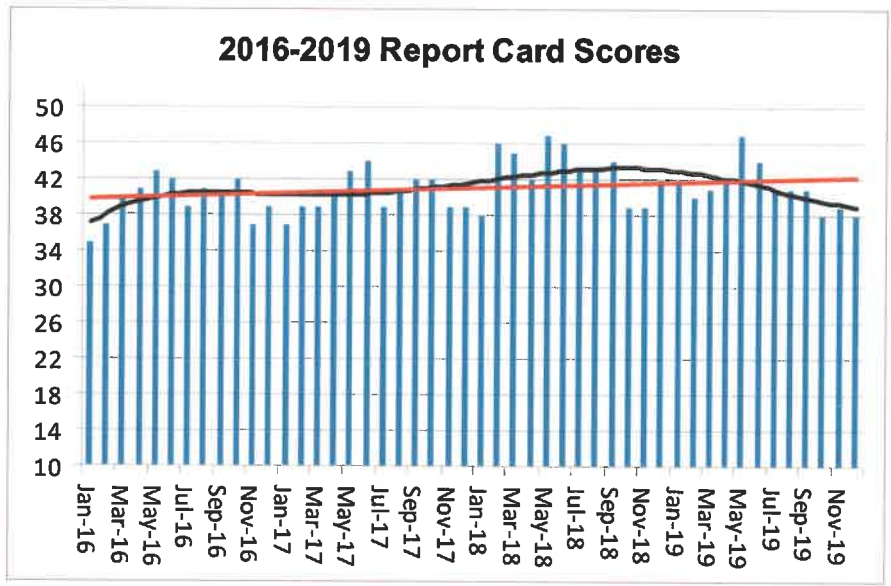
Report card scores for the past three years have been graphically summarized below. Polynomial regression analysis (black line) still indicates a somewhat cyclic pattern, with recent declines. Linear regression analysis (red line) indicates an overall increasing trend in score.
