14 July 2020

Ms. Debbie Tribioli The Oasis at Anozira c/o Kinney Management Services 6303 South Rural Road Tempe, Arizona 85283

Ref: Oasis Lake, May 2020

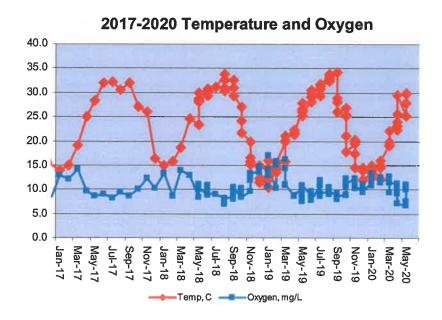
**Temperature, Oxygen, and pH**: Water temperature increased to 25.3 C (77 F) and the dissolved oxygen concentration was at 83 percent saturation (6.8 mg/L). Operation of the floating fountains, as well as the trial nanobubble oxygenation system, helped maintain dissolved oxygen at a level that was satisfactory for the fishery.

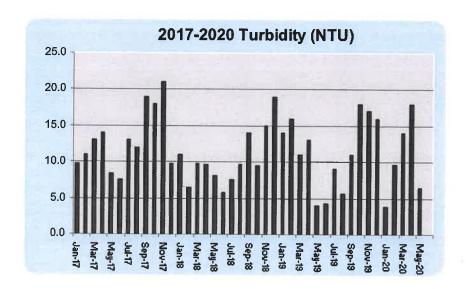
**Turbidity**: The turbidity of the lake water decreased significantly to 6.4 NTU. Water turbidity is impacted by algae density and dissolved and particulate matter in the water, including storm water runoff and dye that is periodically added for algae and weed management. As turbidity increases, clarity decreases. The trend shows an end to consistent increases over the last four months.

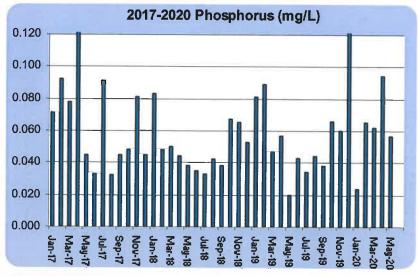
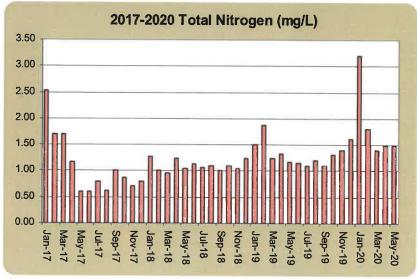
The phosphorus concentration decreased to 0.057 mg/L as P. The total nitrogen concentration was stable at 1.48 mg/L as N. Nitrate, immediately available to algal cells, was at a concentration of 0.08 mg/L. A decrease in nutrient concentrations was evident and a corresponding decrease in algae growth would be expected and occurred.

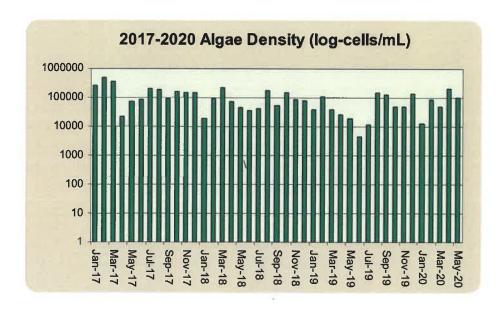
**Phytoplankton (algae)**: The amount and types of algae in a lake dictate the aesthetic and operational quality of the water. Algae density affects the clarity and color of the water, two very important aesthetic criteria. The species composition dictates the form of growth observed; floating mats, suspended cells, stringy attached filaments, etc. It also impacts the choice, frequency, and dosage of herbicides used for water quality management.

As predicted, the total algae density in the lake decreased to 9.65 X 10<sup>4</sup> cells per mL, a density now considered moderate for an urban reservoir in metro-Phoenix. Often-problematic bluegreen (Cyanophyta) algae (*Oscillatoria*, *Spirulina*) comprised about 30 percent of the total assemblage. The dominant alga was *Chlorella*, a green unicell.

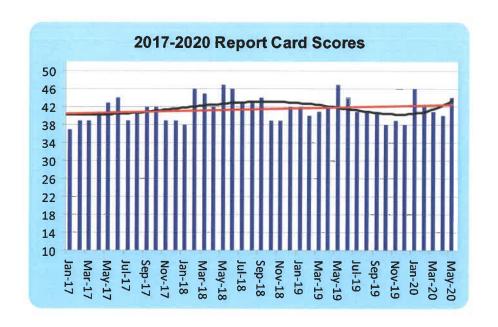
Report card scores for the past three years have been graphically summarized below. Polynomial regression analysis (black line) still indicates a somewhat cyclic pattern. Linear regression analysis (red line) indicates and overall increasing trend in score.
